Tu nel

č. 2
2012

ČASOPIS ČESKÉ TUNELÁŘSKÉ ASOCIACE A SLOVENSKEJ TUNELÁRSKEJ ASOCIÁCIE ITA-AITES
MAGAZINE OF THE CZECH TUNNELLING ASSOCIATION AND SLOVAK TUNNELLING ASSOCIATION ITA-AITES

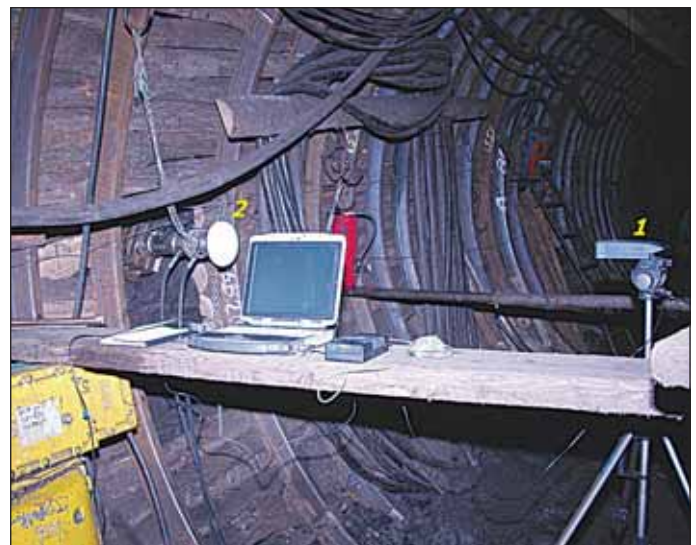
Obr. 1 Ilustrační fotografie systému měření při realizaci tahové zkoušky se záznamem do PC (legenda: 1 – laserový dálkoměr, 2 – tahoměr na instalovaném svorníku)

Fig. 1 Illustration picture of the measurement system during a pull-out test with recording to a PC (legend: 1 – laser distance meter, 2 – tension dynamometer on an installed rock bolt)

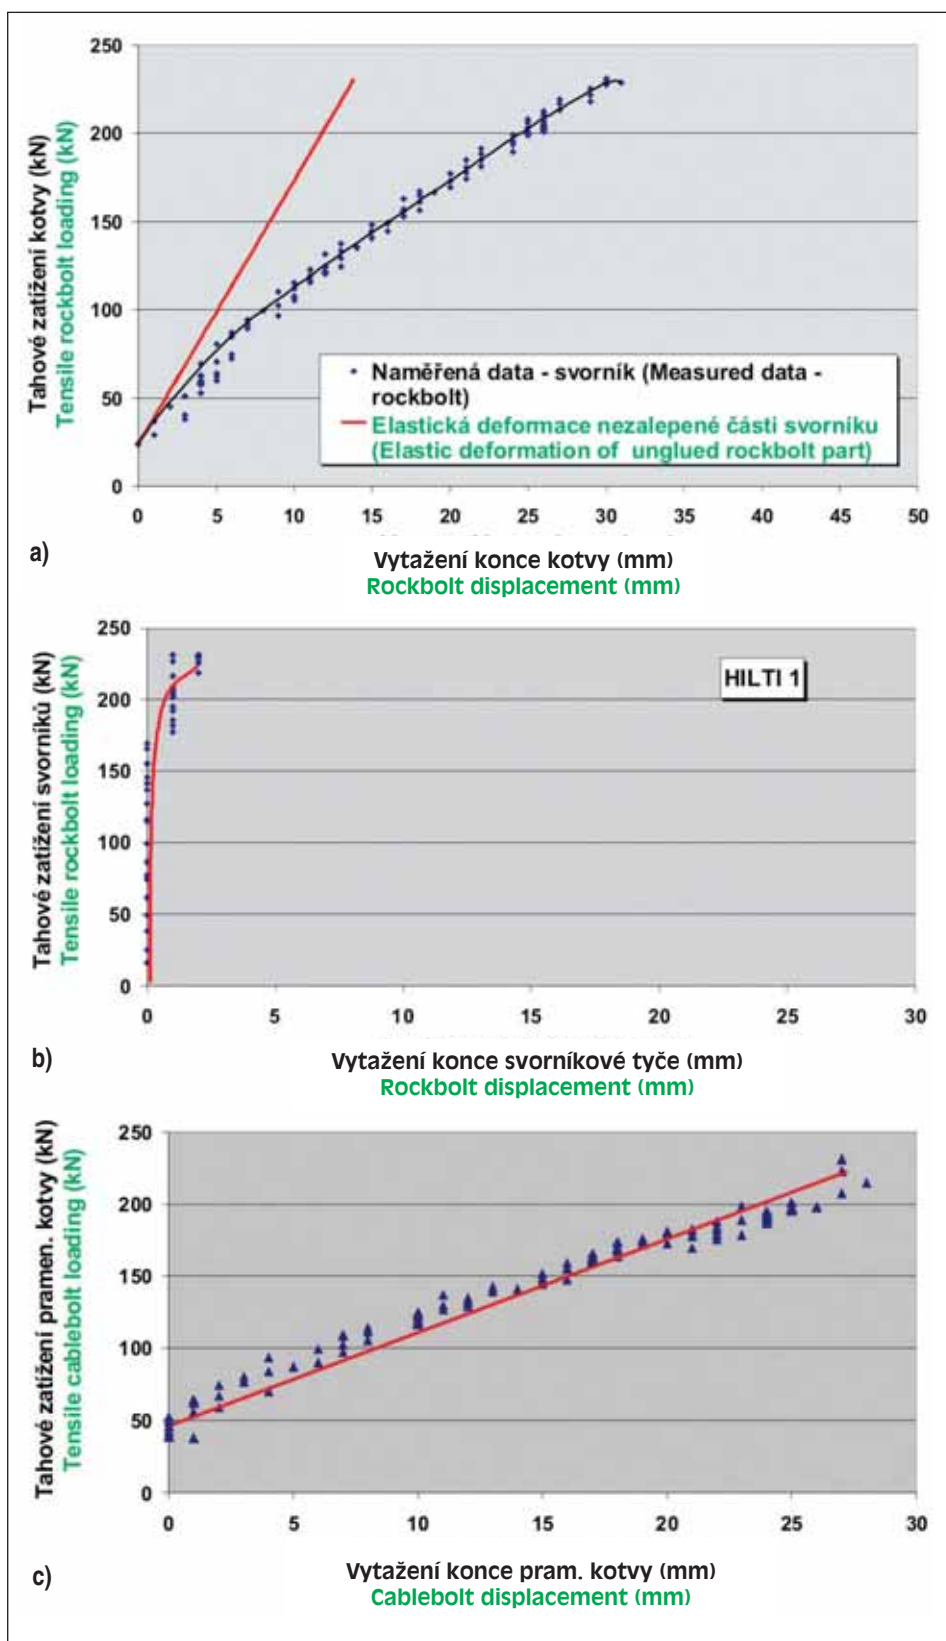
Obr. 2 Pracovní charakteristiky kotevních výztuží

It is advisable in the case of fully encapsulated anchors to plot in the same graph also the characteristics indicating the elastic elongation (deformation) of the non-encapsulated part of the rock bolt being tested, for purposes of assessing the encapsulated and non-encapsulated parts of the rock bolt rod (see Fig. 2a). Typical characteristics of various anchors used in the OKD conditions together with their dynamic characteristics are presented in Figures 2b and 2c below.

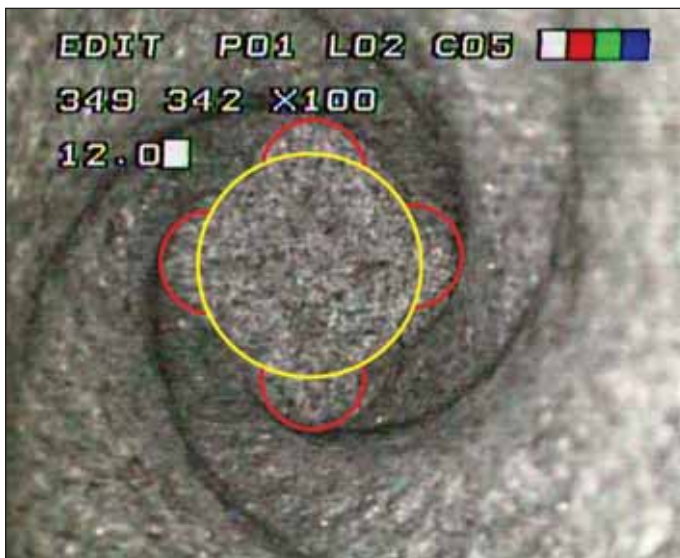
Obr. 5 Vzhled průřezu vrtu se „šroubovicí“ u čelby vrtu, kružnicí je vyznačen plánovaný průměr vrtu, černou barvou jsou naznačeny hranice vykaverno-
vaných oblastí kmitáním vrtné korunky

and the shape of the borehole walls can differ from the required diameter, depending on geological conditions (little strong ground – the fallout of ground from the borehole walls), the drilling regime (resonance vibration of the drill bit causing the development of a “helix” in the borehole, which affects the diameter itself and the borehole volume – see Fig. 5) and the human factor (inappropriately used drill bit diameter etc.). The pull-out tests were conducted on stranded anchors IR 4/C (anchor diameter of 24 mm) with the root about 280 mm long. The anchors were installed in concrete cubes with the edges 300 mm long, concrete uniaxial compression strength of about 50 MPa. One installation borehole about 28 mm, 32 mm and 40 mm in diameter respectively, about 280 mm long, was prepared in the centre of each cube by means of rotary drilling. A stranded anchor was glued into the borehole using Lokset HS Slow polyester resin (see Fig. 6a). Subsequently, about 8 weeks later, these anchors were submitted to pull-out tests. Fig. 6b displays the testing set consisting of the load meter and distance meter used during the test.

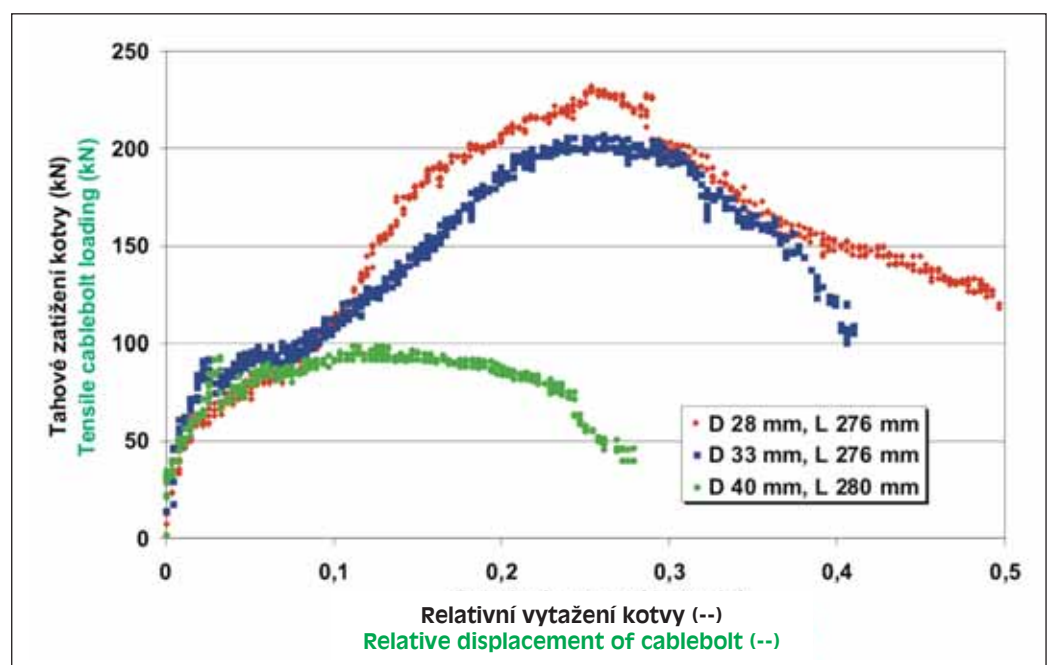
Obr. 7 Typické tahové charakteristiky kotev vlepěných do vývrťů o různém průměru
Fig. 7 Typical pull-out characteristics of anchors glued into boreholes with various diameters

- A well selected borehole diameter and high quality of its installation can significantly favourably affect the pull-out resistance and characteristics of an anchoring element.
- Taking into consideration the potential disproportions in the borehole cross-section, it is necessary to increase the amount of grout injected into the installation borehole. The situation presented in Fig. 5 can be an example. If we assess the area of the assumed and actual cross-section (see Fig. 5), the increase approximately up to 50% is achieved in this case. Such a situation has subsequently to be taken into consideration, for example, when the consumption of grout to be used for the gluing of rock bolts is being estimated.

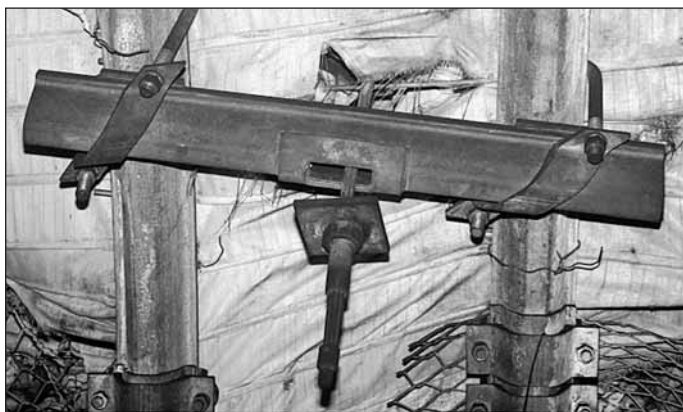
Obr. 8 Ilustrační foto pramencové kotvy ukotvené k obloukové výztuži pomocí rovného nosníku z válcovaného profilu TH (profil pro výrobu důlních obloukových výztuží)

Fig. 8 Illustration photo of a stranded anchor anchored to support arches even by means of a straight TH steel-rolled section beam (a cross-section used for the manufacture of colliery support arches)

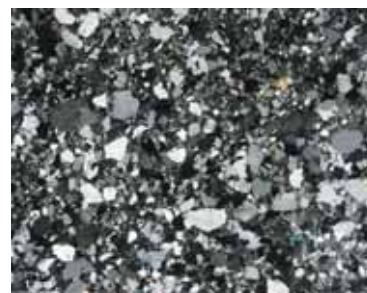
Obr. 2 Petrografické vlastnosti středně zrnitého glaukonitického pískovce
Fig. 2 Petrographical properties of medium-grained glauconitic sandstone

- Biotitic granite, medium grained – „the Silesian Granite“ (see Fig. 1)
- Medium-grained glauconitic sandstone – „the Godul Sandstone“ (see Fig. 2)

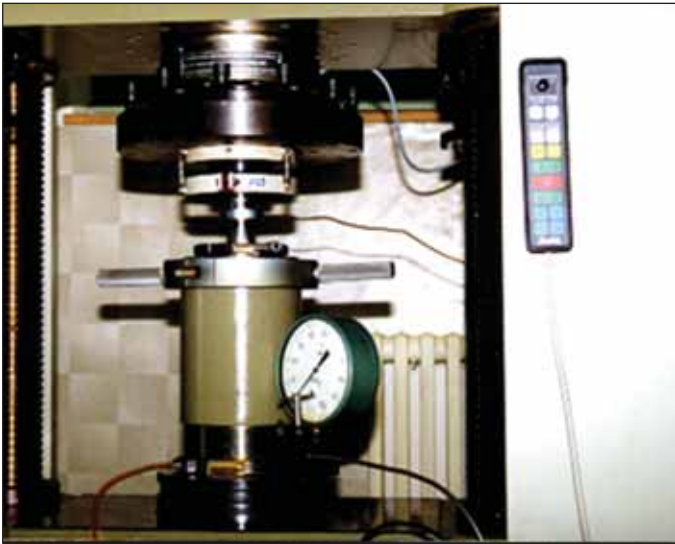
Obr. 3 Triaxiální komora KTK 100
Fig. 3 Triaxial chamber KTK 100

případně až do velikosti 100 MPa, a jako zdroj osového napětí (σ_1) slouží mechanický lis ZWICK 1494 s maximální silou 600 kN, řízený počítačem.

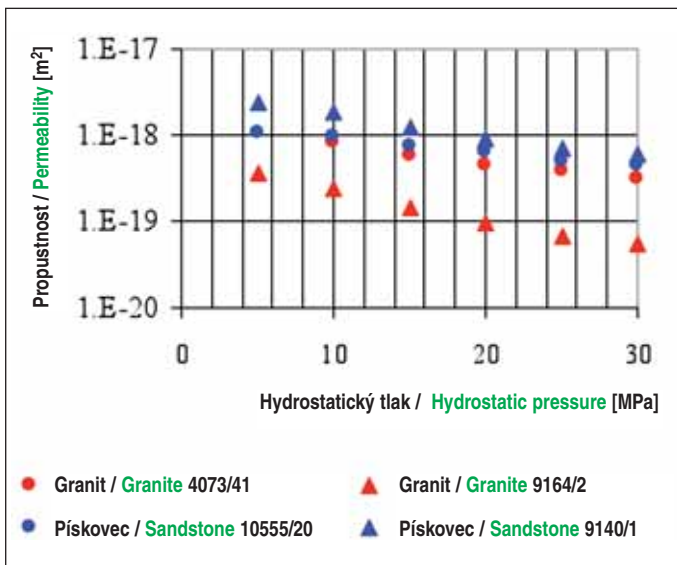
Obr. 5 Závislost propustnosti na velikosti hydrostatického tlaku
Fig. 5 Permeability-hydrostatic pressure curve

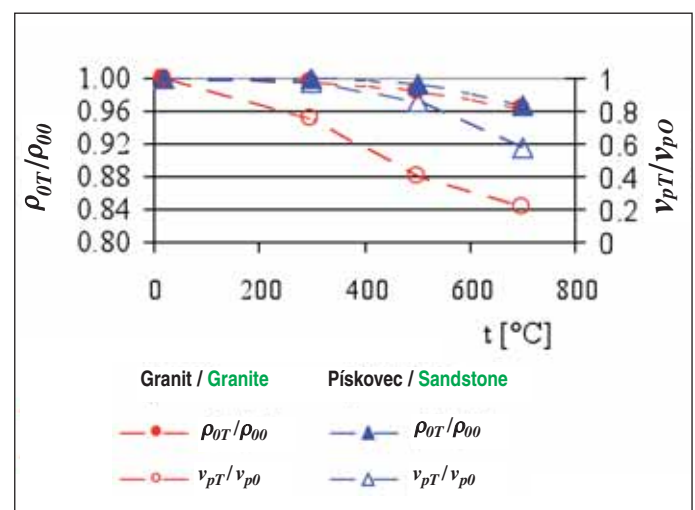
Obr. 7 Změny poměru ρ_{0T}/ρ_{00} a v_{pT}/v_{p0} v důsledku „teplotního šoku“
Fig. 7 Changes in the ρ_{0T}/ρ_{00} and v_{pT}/v_{p0} ratio caused by the “thermal shock”

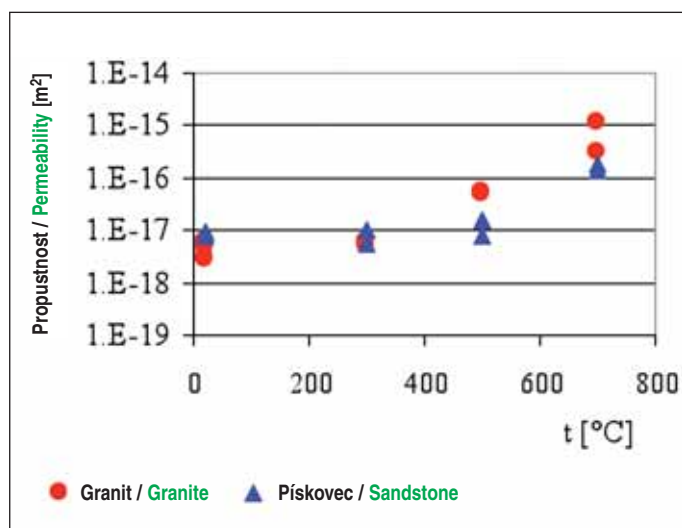
Obr. 8 Změny propustnosti za trojosého stavu napjatosti 5 MPa v důsledku „teplotního šoku“

The permeability was measured on test specimens exposed to the temperatures of 300°C, 500°C and 700°C at the triaxial (hydrostatic) state of stress of 5 MPa. The influence of the thermal shock on permeability is presented in Figure 8.

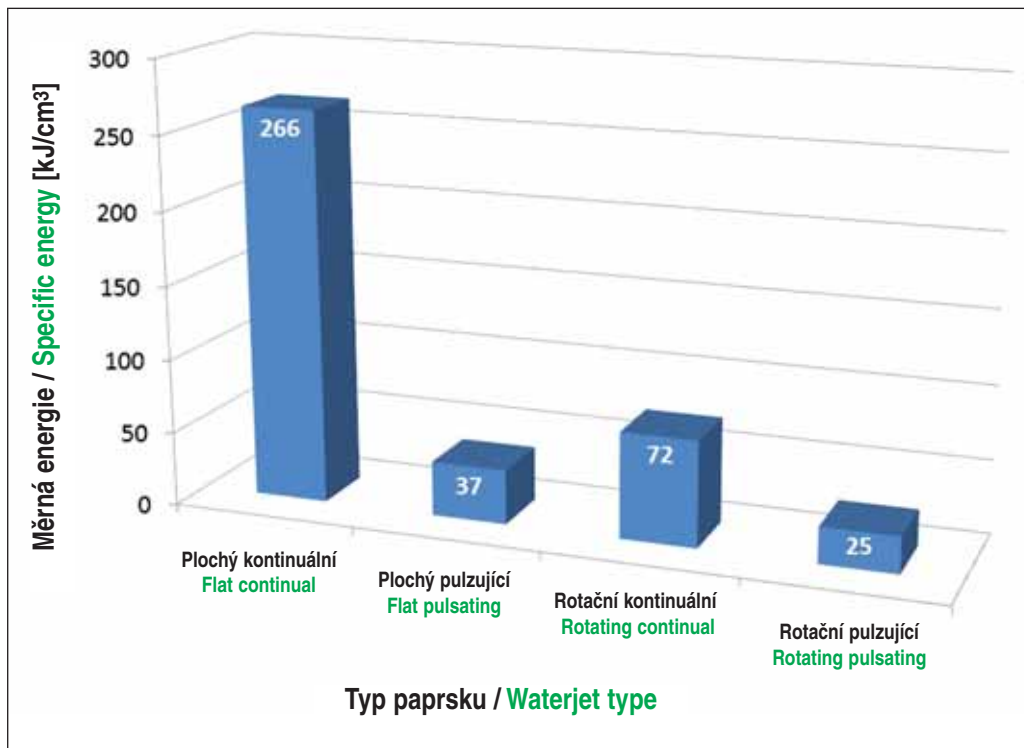
Obr. 2 Měrná energie potřebná k rozpojení 1 cm³ betonu u zkoumaných typů paprsku
 Fig. 2 Specific energy required for disintegration of 1 cm³ of concrete for tested jet types

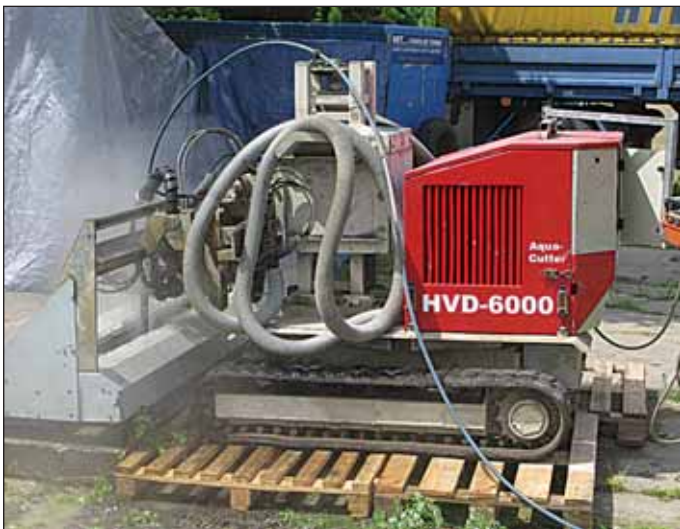
Obr. 5 Pásový manipulátor Aqua Cutter HVD-6000
Fig. 5 Caterpillar manipulator Aqua Cutter HVD-6000

The experimental equipment consisted of a source of high-pressure water, a system generating high-frequency pressure pulsations in the high-pressure system and a tracked manipulator allowing oscillation motion of the nozzle (see Fig. 5) concurrently with the traverse motion of the oscillating nozzle over the panel being tested.

generování vodních paprsků byly použity standardní průmyslové trysky různých průměrů s různou vnitřní geometrií. Použitý pásový manipulátor Aqua Cutter HVD-6000 (obr. 5) pro plošné odstraňování povrchových vrstev vodním paprskem umožňoval programovatelný pohyb trysky nad povrchem.

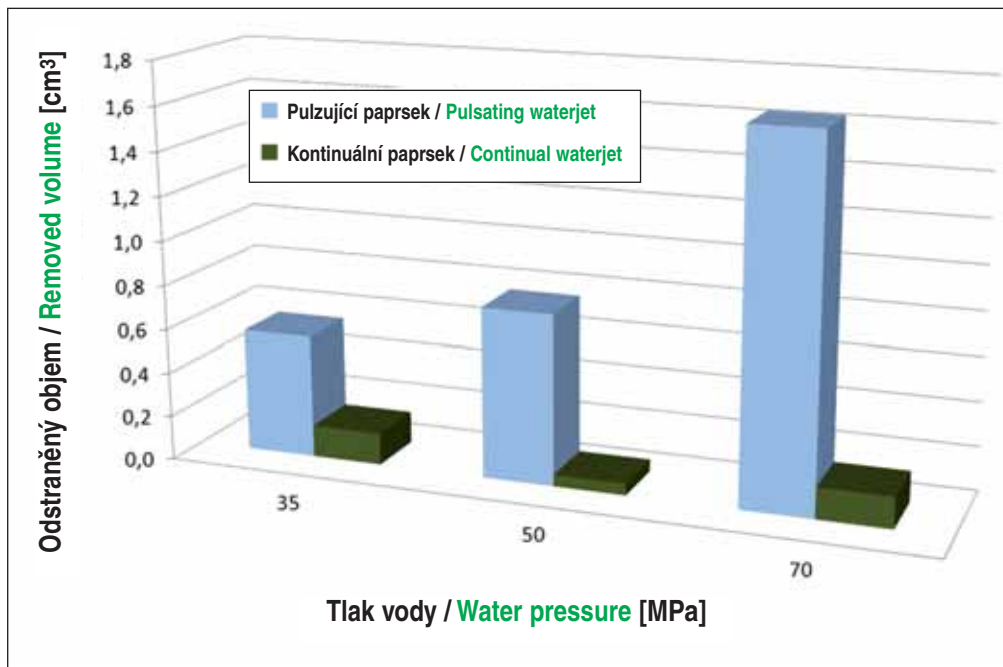
Obr. 8 Porovnání účinnosti oscilujících paprsků s kruhovým průřezem
Fig. 8 Comparison of efficiency of oscillating round jets

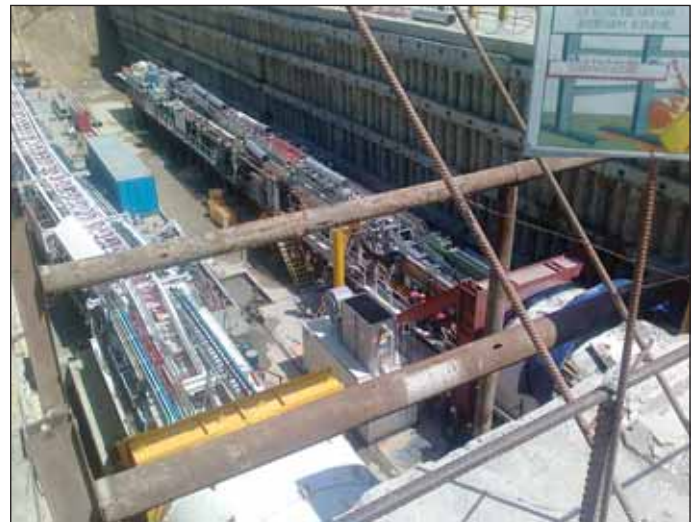
Obr. 2 Pohled na montáž štítů Robbins a Herrenknecht ve stavební jámě B01
Fig. 2 A view of the Robbins and Herrenknecht shields assembly in the B01 construction pit

Východní tunelová trouba se razí strojem od výrobce „Robbins“ a západní trouba se razí strojem od výrobce „Herrenknecht“. V obou případech se jedná o zeminové štíty (EPBS), které se dobře chovají ve zde zastížených tuhých jílech, ale hůře již zvládají často přítomné vápencové lavičky a zvodnělé pískovcové vrstvy lokalizované pod hladinou podzemní vody. Segmentové ostění pro východní tunelovou troubu je navrženo na systém skladby segmentů 5+1 a všechny prstence jsou stejné, tedy symetricky zkosené. Naproti tomu ostění západní tunelové trouby je navrženo na systém skladby 6+1 a existují zde dva druhy prstenců (pravé a levé), které mají vždy jednu hranu svislou a druhou zkosenou. Dále se segmenty liší v umístění a počtu nik pro spojování segmentů. Délka prstence pro východní tunelovou troubu je 1,5 m, pro západní tunelovou troubu 1,2 m. Šrouby, které spojují jednotlivé segmenty v prstenci a jednotlivé prstence mezi sebou jsou uvažovány jako dočasné po dobu výstavby do doby, než dojde k nárůstu pevnosti injektáže mezi segmentovým ostěním a zeminovým/horninovým prostředím. Následně jsou demontovány a opět použity na nově sestavované prstence. Vzdálenost pro demontáž dočasných šroubů se liší podle použité injektáže a v případě štítu Herrenknecht se šrouby demontují ve vzdálenosti cca 70 m za čelbou. Nutno dodat, že tyto dočasné spojovací prvky jsou ponechány v místech zavěšení pásového dopravníku odnášejícího rubaninu, v místech propojek až do doby odstranění ocelového ztužujícího rámu a +/- 10 m také za/před stanicemi, kde jsou před finalizací tratových tunelů vyměněny za trvalé, galvanizované.

Oba tunelovací stroje umožňují přítlak na čelbu, u štítu Herrenknecht je možno dosáhnout až 4,5 baru, u štítu Robbins je možno dosáhnout 5 barů. I přes tyto tlaky není ražba, mnohdy ve značných hloubkách pod hladinou podzemní vody, úplně jednoduchá. Průměrné denní výkony ražby se pohybují kolem 10–12 m, v případě složitých geologických podmínek je to jen kolem 4 m, a to zejména ve vápencových vrstvách s vyšším sloupcem vody nad úrovní ražby. Dalším podstatným rozdílem obou strojů je, že stroj Robbins je obsluhován pouze kolejovou dopravou, a to jak pro odvoz vytěženého materiálu, tak i pro dopravu segmentů na čelbu. Stroj Herrenknecht používá pro dopravu segmentů na čelbu staveništní vlak a transport vytěženého materiálu zajišťují kontinuální dopravníkové pásy. Start obou štítů probíhal skrze pilotovou stěnu opřením o ocelovou

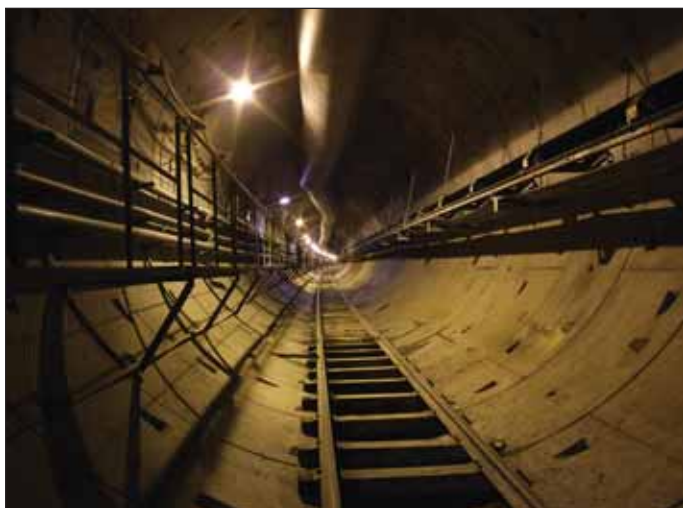
Obr. 3 Pohled do západní tunelové trouby
Fig. 3 A view down the western tunnel tube

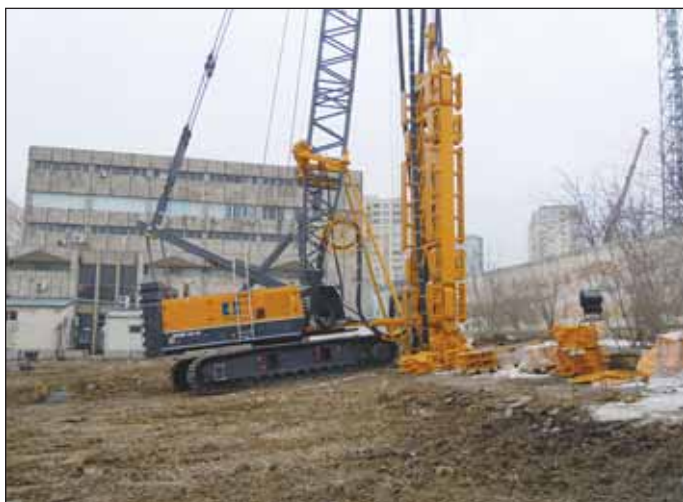
Obr. 8 Provádění podzemních stěn pomocí hydrofrézy
Fig. 8 Installation of diaphragm walls by means of a hydro-cutter

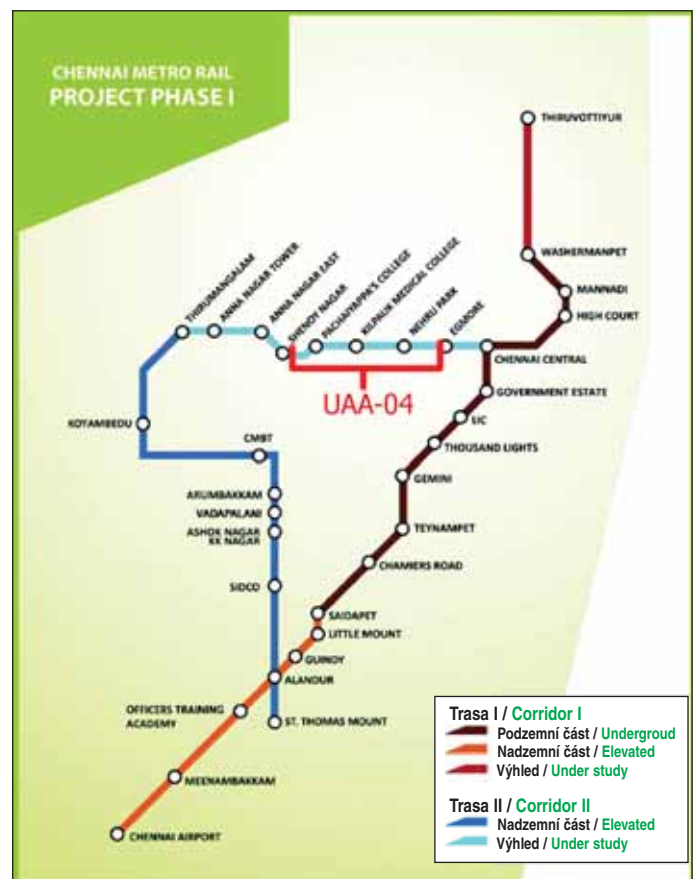
Obr. 1 Rozsah úseku UAA-04 v rámci celého projektu (Chennai Metro Rail Limited)

Fig. 1 The extent of the UAA-04 section within the whole project (Chennai Metro Rail Limited)

awarded to different contractors using the Design & Build procurement system. This paper describes the section with the working designation UAA-04. It is a 3.7 km long underground section of the route comprising a pair of running tunnels driven by full-face earth pressure balance (EPB) shields, including 12 conventionally driven cross passages and three cut-and-cover build stations: Nehru Park, Kilpauk Medical College and Pachaiappa College (see Fig. 1).

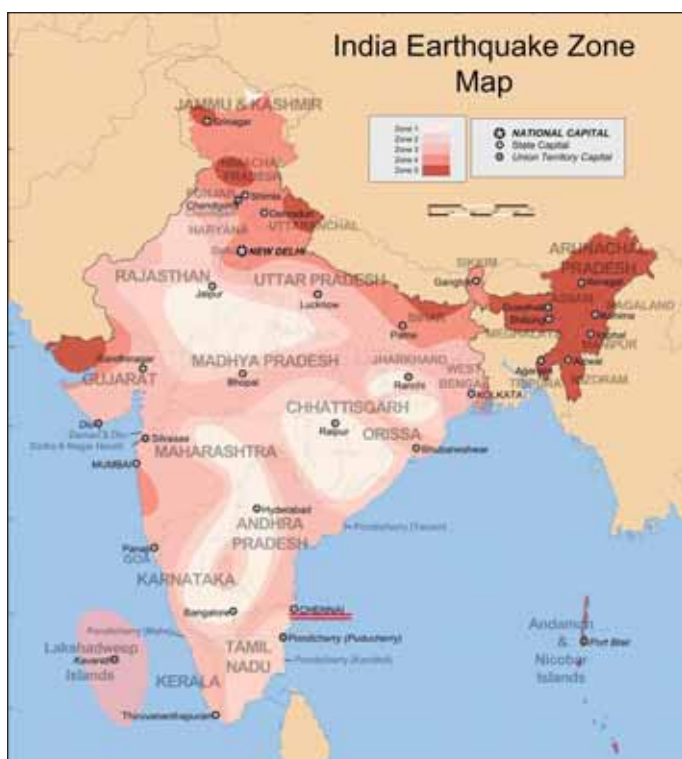
Obr. 2 Seismická mapa Indie (Wikipedia)
Fig. 2 Seismic map of India (Wikipedia)

0.135–0.152 g, depending on the specific depth of the running tunnels under the ground surface. These values were further used when inner forces in the segmental lining were being calculated. They differ from the classical calculation, even though non-linear physical models of soil are used, in the range of 135 – 280 % (the reader can compare them with a similar calculation for cross passages referred to below, the magnitude of which is smaller). Obviously this value is absolutely non-negligible. The influence of seismic loading on reinforced concrete segments was assessed analytically, according to relationships and algorithms commonly available, and also numerically, using the Finite Element Method taking non-linear physical models of soils into consideration. Advanced constitutive models acquitted themselves best for the FEM numerical simulation. They exhibit relatively high degree of agreement with reality, whilst linearly elastic-perfectly plastic models without manual interaction were used only for preliminary predictions. Of course, the input parameters affect the selection of the particular model to the maximum. For that reason efforts were made to use not only the recommended geological interpretation, but also to delve into sets of laboratory tests and develop a well-arranged package of input data for parametric studies.

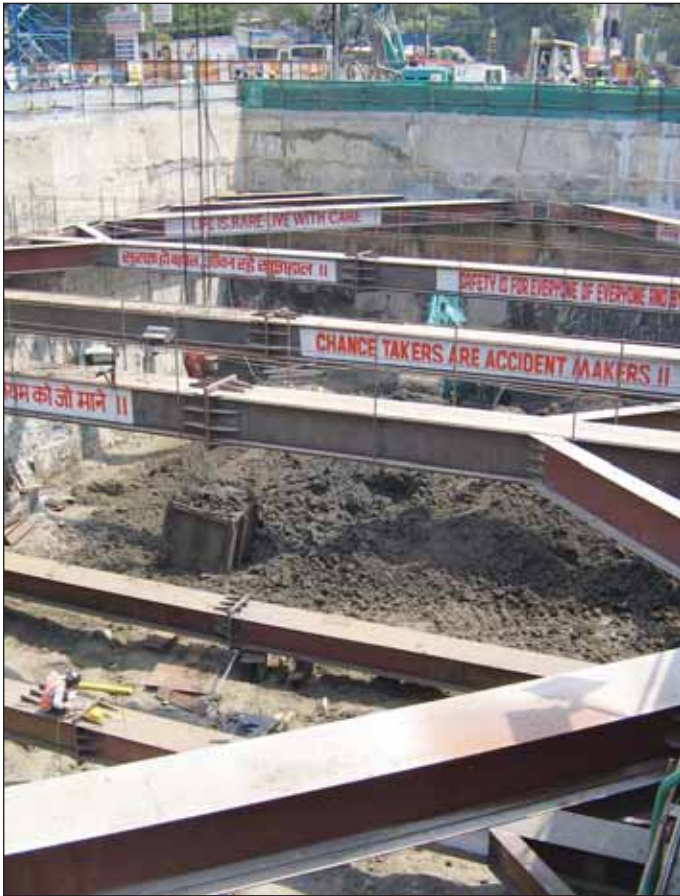
Obr. 3 Rozpíraná stavební jáma montážní šachty Nehru Park
Fig. 3 Braced construction pit for the Nehru Park assembly shaft

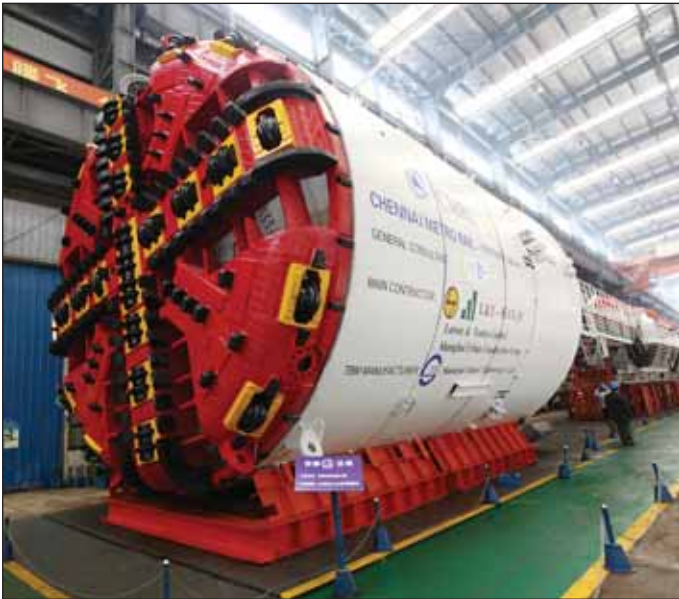
Obr. 4 EPBS č. 1 ve výrobním závodě v Číně
Fig. 4 EPBS No. 1 in the manufacturing plant in China

Two full-face EPB TBMs 6.68 m in diameter, with the thrust of 35,000 kN, manufactured by Chinese company SMEC (Shanghai Tunnel Engineering Company) were chosen for the driving of tunnels at the total length of 2x3.4 km (see Fig. 4). Both tunnel tubes will be driven starting from the above-mentioned launching shafts located in the cover-and-cut stations and ending in dismantling shafts, which will also be located in the spaces of the

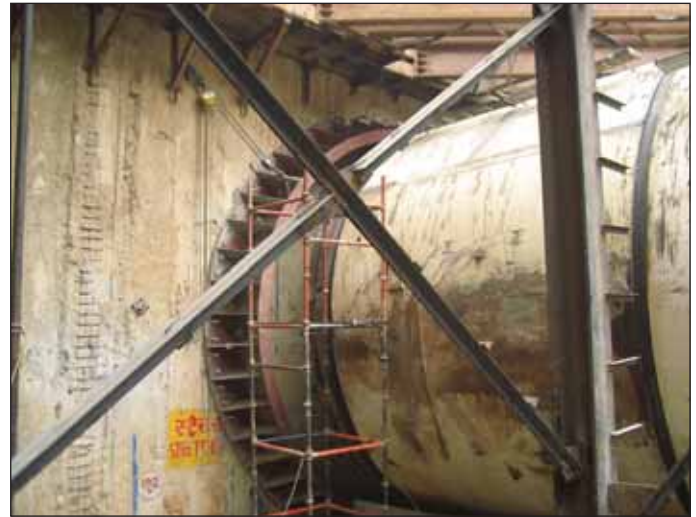
Obr. 6 Ocelový prstenc pro průchod EPBS z projektu metra v Dillí
Fig. 6 Steel ring for the passage of the EPBS used on the Delhi Metro project

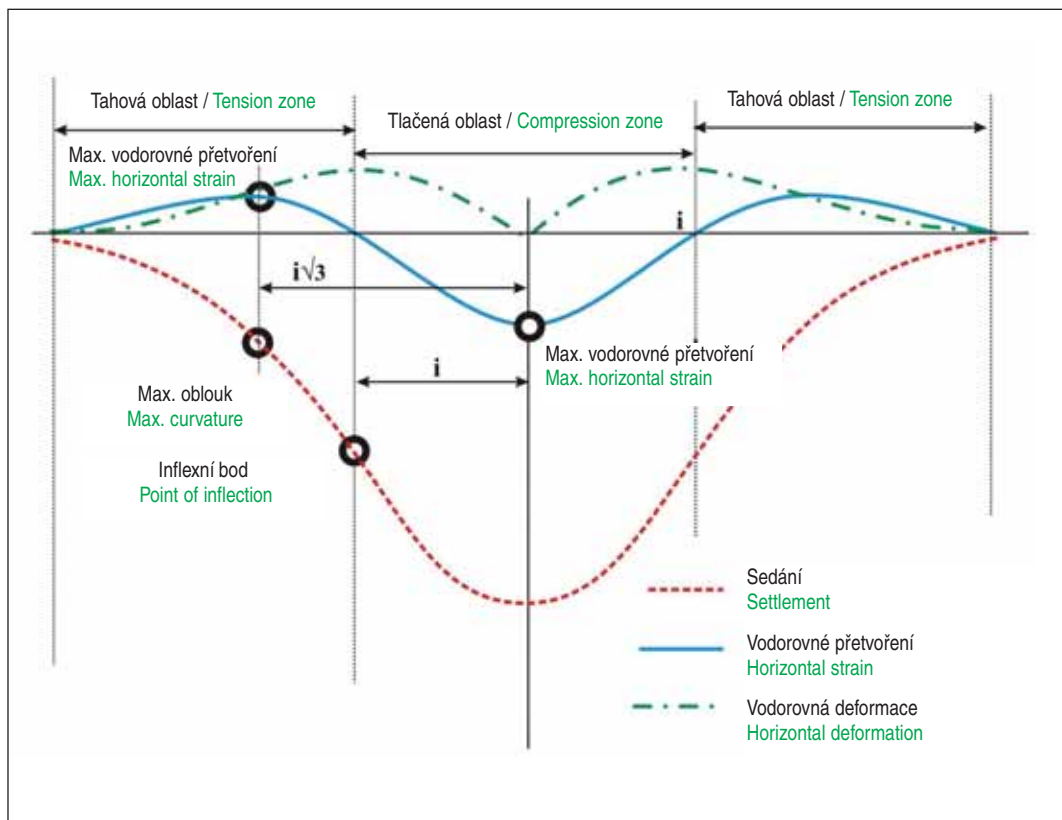
Obr. 1 Teoretický průběh poklesové kotliny
Fig. 1 Theoretical shape of the settlement trough

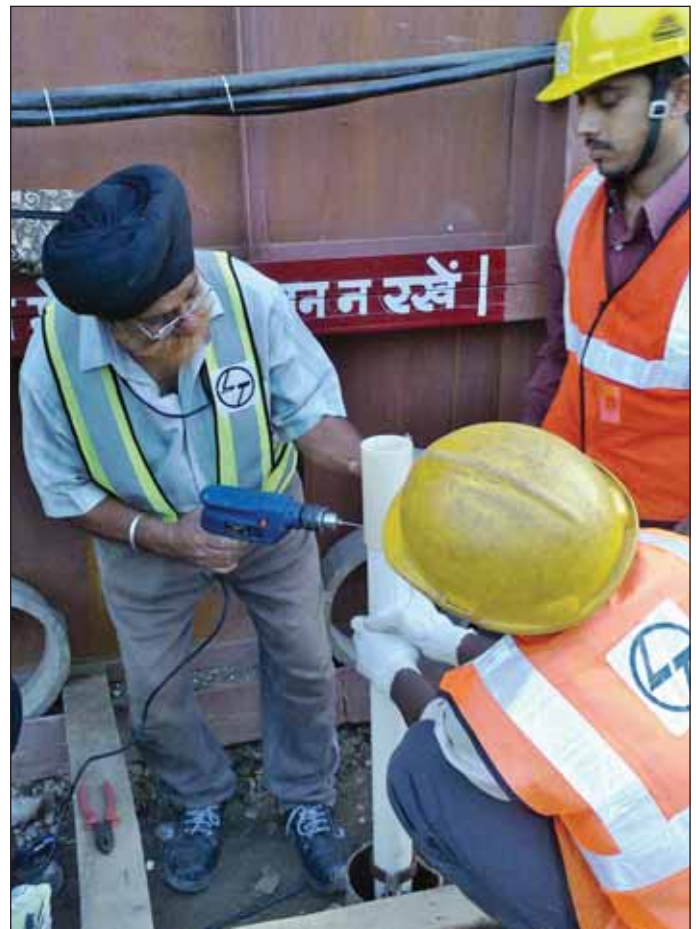
Obr. 3 Montáž inklinometrické pažnice ve vrtu

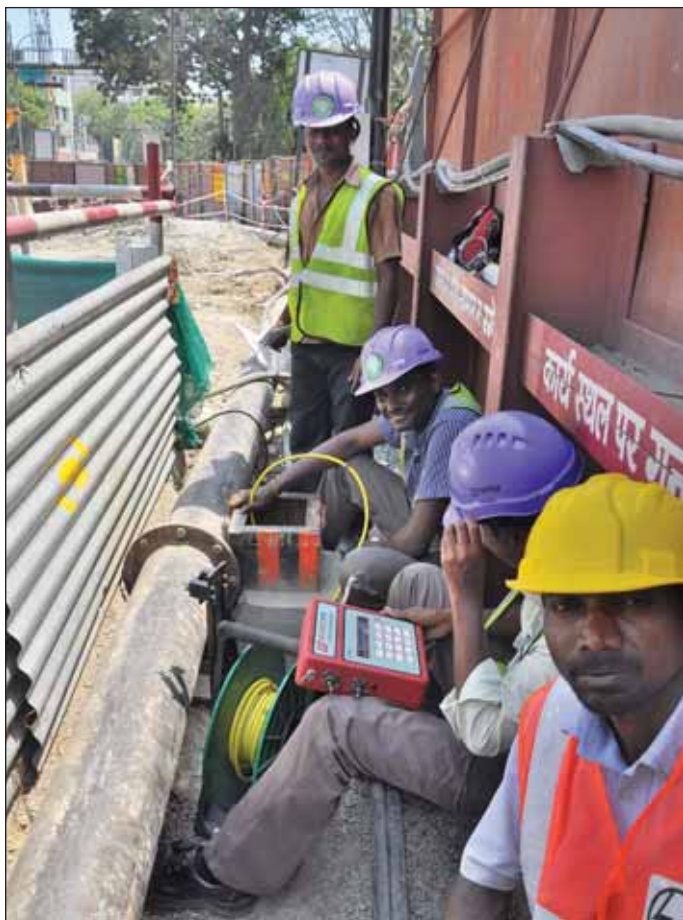
Obr. 4 Inklinometrické měření v konstrukci podzemní železobetonové stěny
Fig. 4 Inclinometer measurement in a reinforced concrete diaphragm wall structure

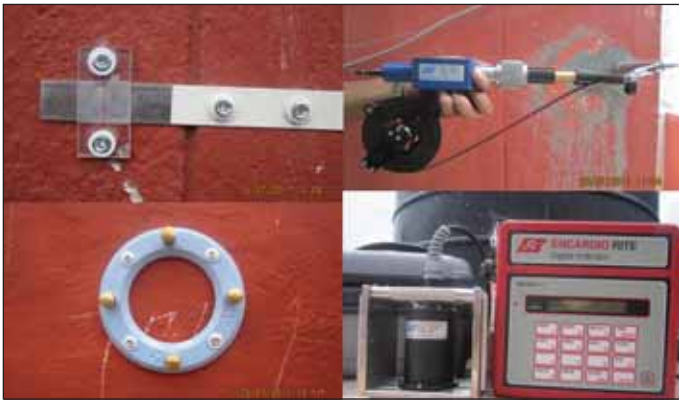
Obr. 6 Příklad instrumentace objektů povrchové zástavby
Fig. 6 An example of the instrumentation of existing surface buildings

- levelling survey
- measurement of inclination of high-rise buildings (tiltmeters and trigonometric survey)
- measurement of expansion of cracks (dilatometers)
- measurement of horizontal deformation of structural enclosing walls (tape extensometers)
- measurement of vibrations inside buildings

Each building is instrumented individually, depending on the number of floors, the structural design and position of the building within the settlement trough. The settlement of each building will be periodically measured around the building circumference using the precise levelling technique, taking

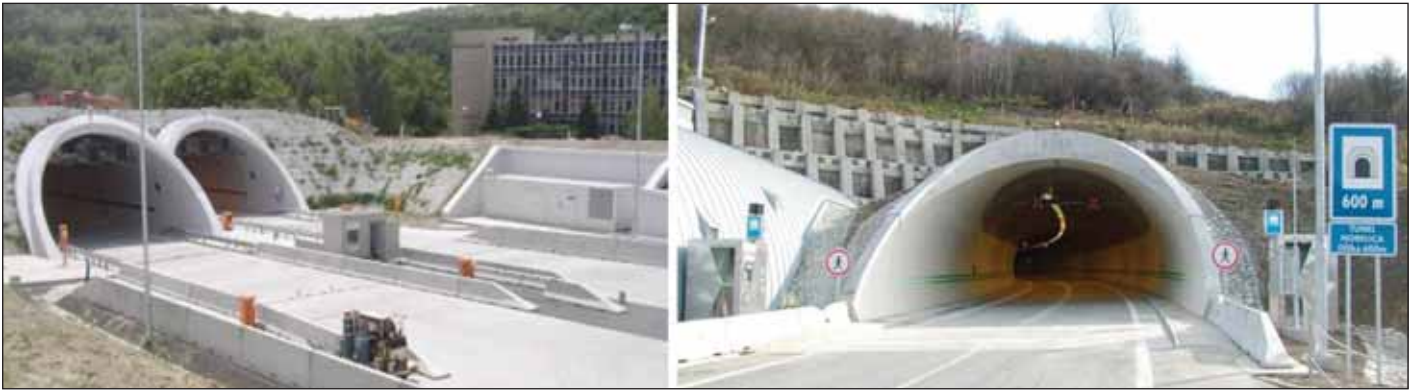
Obr. 1 Pohľady na CB vozovky – vľavo tunel Sitina na D2 (Ing. Dušan Todák), vpravo výjazd z tunela Horelica na trase D3 (<http://dialnice.szm.com/tunnels/Horelica.htm>, 22. 3. 2012)

Fig. 1 Views of CP: left – the tunnel Sitina D2 (Ing. Dušan Todák), right – the exit from Horelica tunnel on highway D3 (<http://dialnice.szm.com/tunnels/Horelica.htm>, 22. 3. 2012)

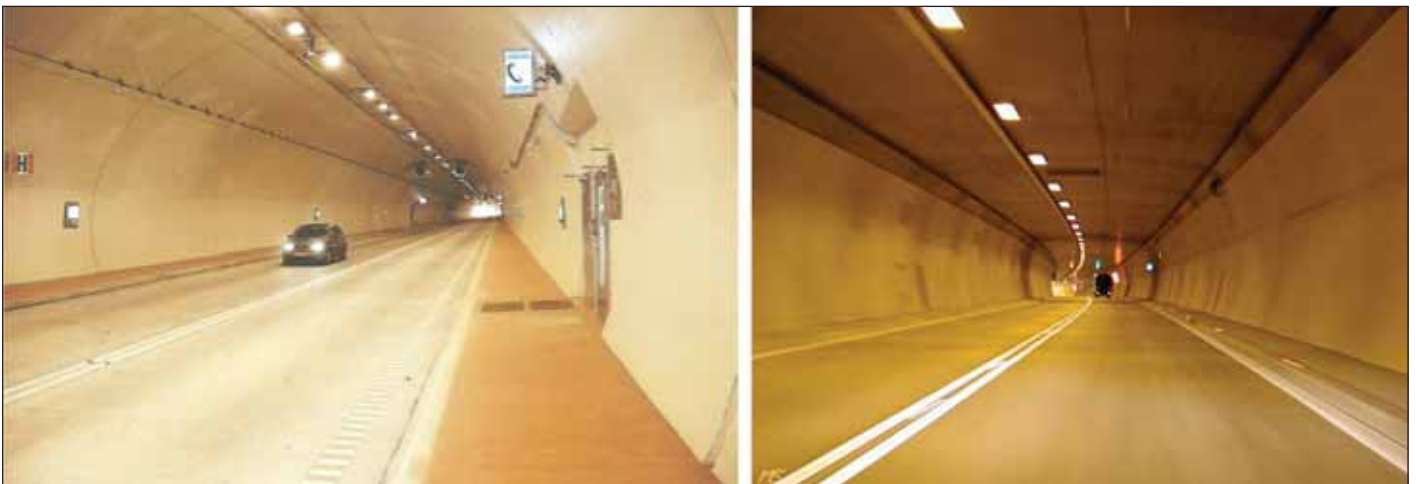
Obr. 2 Pohľady na CB vozovky na diaľnici D1 v tuneloch Bôrik (Ing. Ján Filipovský) a Branisko (http://www.railweb.sk/Foto/Foto_bran.html, 20. 3. 2012)

Fig. 2 Views on CP in tunnels Bôrik (Ing. Ján Filipovský) and Branisko (http://www.railweb.sk/Foto/Foto_bran.html, 20. 3. 2012) on highway D1

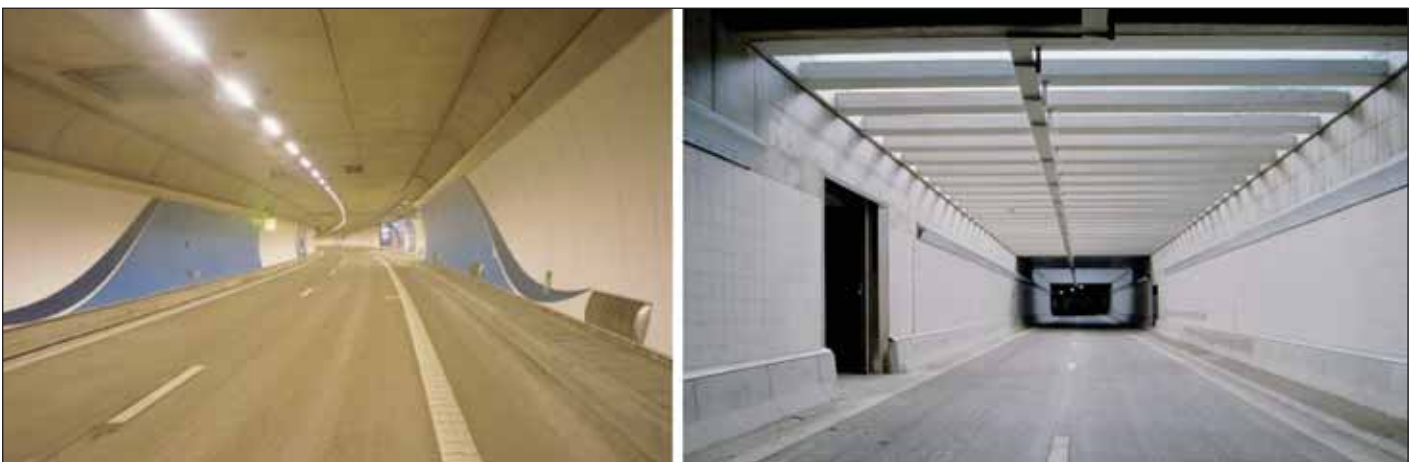
Obr. 3 Tunely Cointe (<http://minel-schreder.rs/en/applications/grouppreferences.html>, 20. 3. 2012) a Kinkempois (<http://www.ori.be/fr/projets/tunnel-de-kinkempois>, 20. 3. 2012) v Belgicku na E25-E40 v Liege s použitím CB vozovky

Fig. 3 Tunnels in Belgium with CP pavements: left – tunnel Cointe (<http://minel-schreder.rs/en/applications/grouppreferences.html>, 20. 3. 2012), right – tunnel Kinkempois (<http://www.ori.be/fr/projets/tunnelde-kinkempois>, 20. 3. 2012) on E25-E40 in Liege

Abroad, situation is not that evident as in SR, in tunnels are building not only concrete (Fig. 3 and 4), but also asphalt pavement (Table 2).

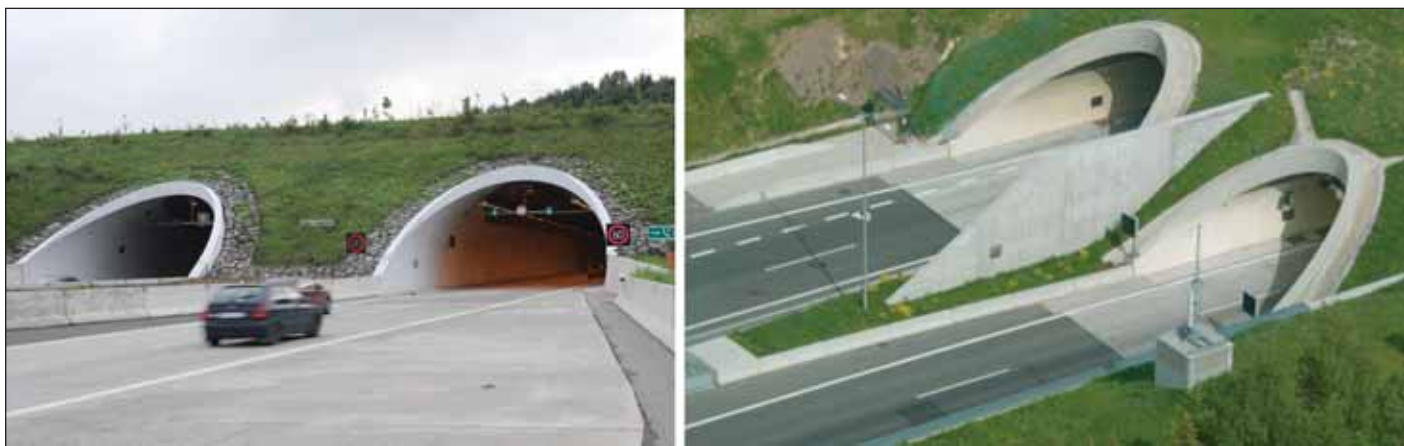
Obr. 4 Klimkovice (<http://www.dopravniinfo.cz/ridici-centrum-tunelu-klimkovice>, 23. 3. 2012) na D1, Panenská (<http://www.valbek.cz/cs/reference/tunely>, 20. 3. 2012) na D8

Fig. 4 Tunnels in ČR with CP: left – Klimkovice (<http://www.dopravniinfo.cz/ridici-centrum-tunelu-klimkovice>, 23.3.2012), right – tunnel Panenská on D8

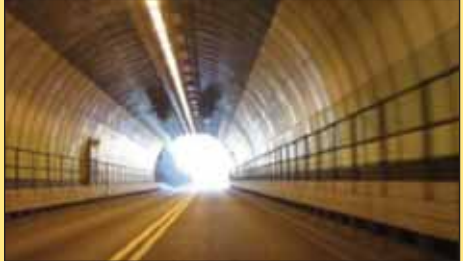
<p>Poľsko Poland</p> <p>Tunnel Wisłostrady</p>	<p>Tunel Wisłostrady, length 700 m, obrusná vrstva AC O 16, PMB 25/55–63, 50 mm [4]. / Wisłostrada tunnel, length 700 m, wearing course: 5cm asphalt concrete AC 16, PMB 25/55-63 [4]</p>

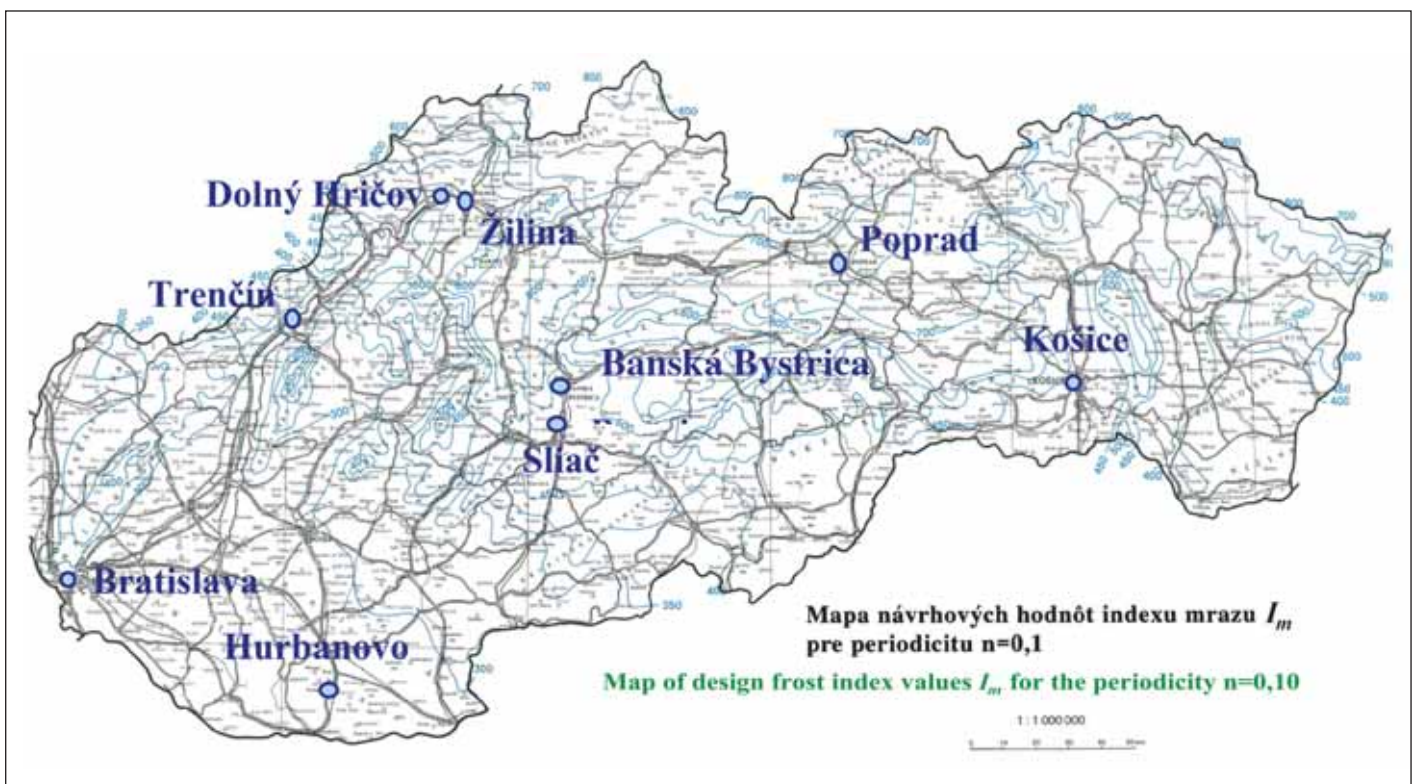
Obr. 5 Lokalizácia meteorologických staníc zvýraznená v mape návrhových hodnôt indexu mrazu pre periodicitu $n=0,10$ podľa STN 73 6114 [5]
 Fig. 5 Location of meteorological stations highlighted on the map of frost index values for the periodicity $n=0,10$ according to STN 73 6114 [5]

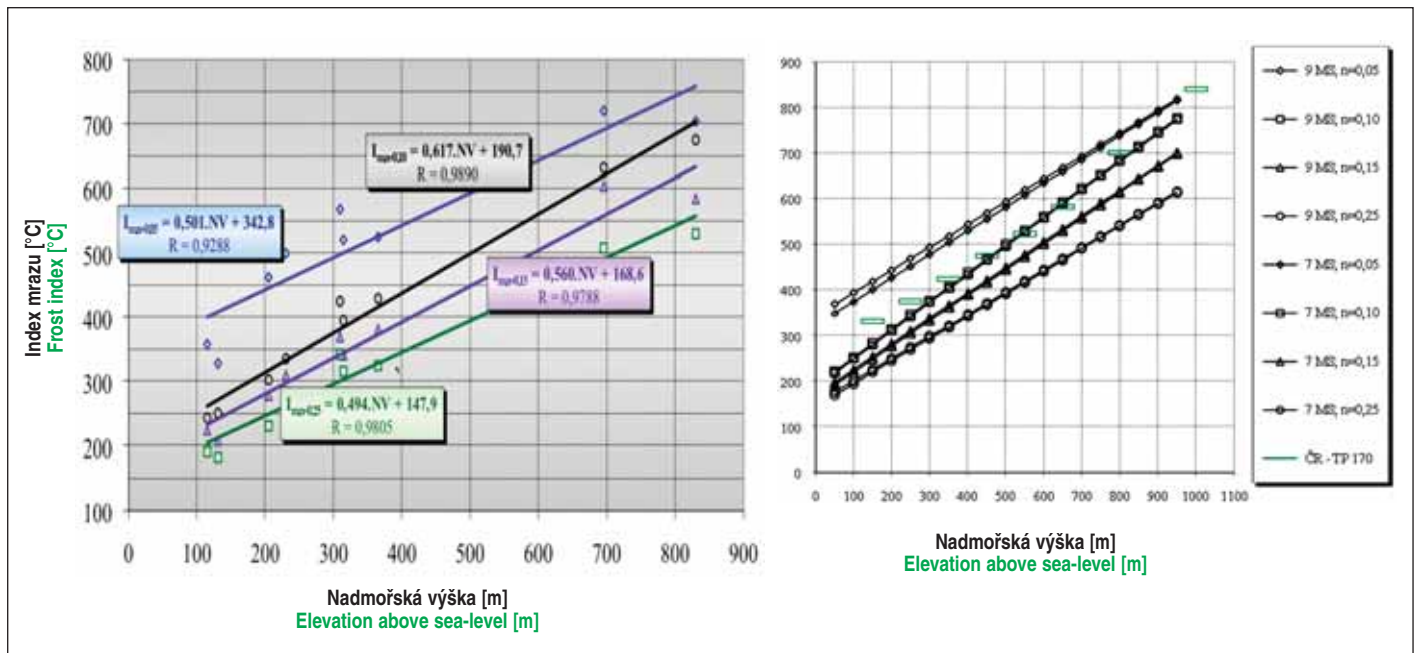
Obr. 6 Objektivizované korelačné závislosti indexu mrazu od nadmorskej výšky za obdobie 1971 až 2000 [7] a porovnanie korelácie pre n=0,10 s TP 170 [8]
 Fig. 6 Objectified correlation dependence of the frost index from above sea-level for the period from 1971 to 2000 [7] and comparison of correlation for n=0,10 s TP 170 [8]

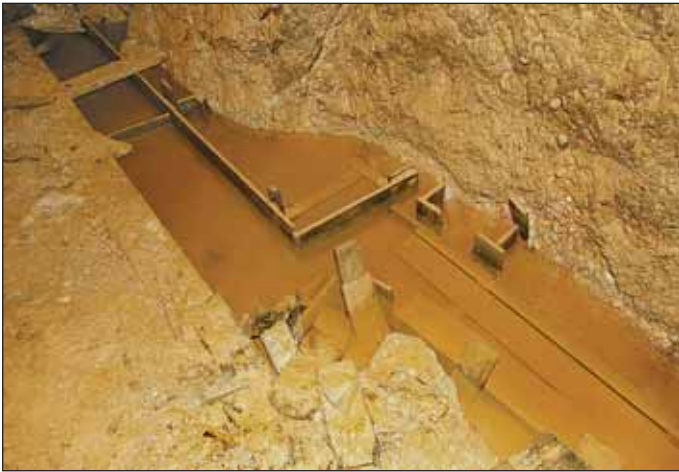
Obr. 2 Bednění základů ostění v podzemí tvrze Stachelberg
Fig. 2 Formwork for foundations of the lining in the Stachelberg fortress underground

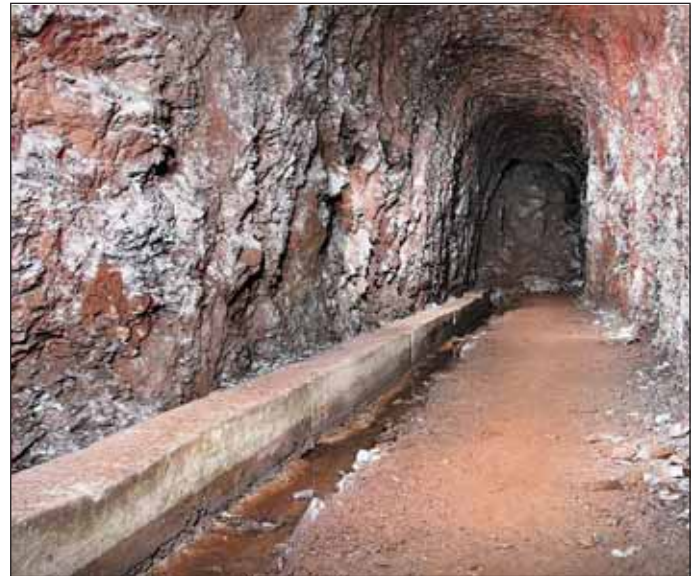
Obr. 3 Vybetonovaný základ ostění v podzemí tvrze Dobrošov
Fig. 3 Completed concrete foundation of the lining in the Dobrošov fortress underground

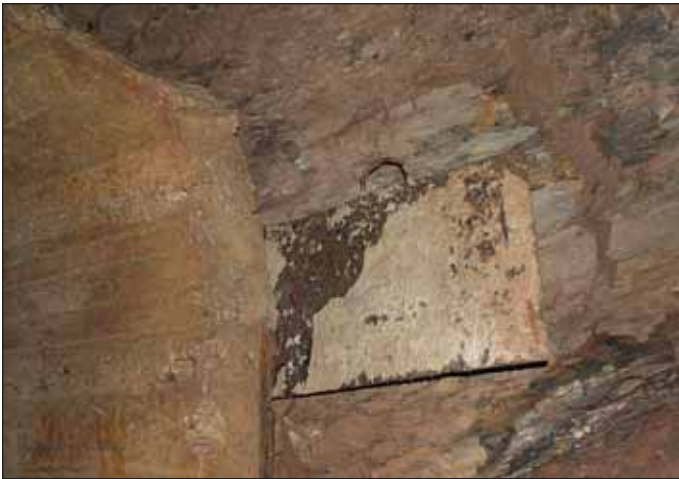
Obr. 7 Bednicí plech v podzemí tvrže Dobrošov
Fig. 7 The steel sheet used for formwork in the Dobrošov fortress underground
