Tu nel

č. 2
2012

ČASOPIS ČESKÉ TUNELÁŘSKÉ ASOCIACE A SLOVENSKEJ TUNELÁRSKEJ ASOCIÁCIE ITA-AITES
MAGAZINE OF THE CZECH TUNNELLING ASSOCIATION AND SLOVAK TUNNELLING ASSOCIATION ITA-AITES

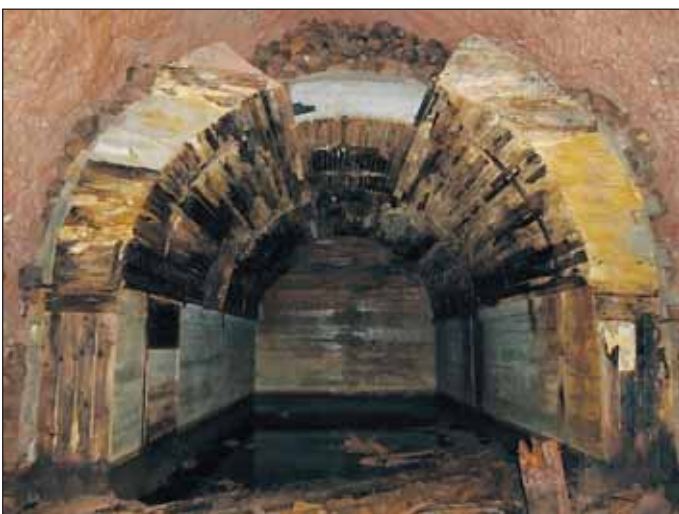
Obr. 8 Pozůstatky bednění sálu profilu 400/400 v podzemí tvrže Stachelberg; v popředí fragment stojky z výdřevy, zajišťující výlom provedený v sousedním pasu
Fig. 8 Remains of formwork for a 400/400-profile hall in the Stachelberg fortress underground. A fragment of a timbering post supporting the excavation completed in the neighbouring block can be seen in the foreground

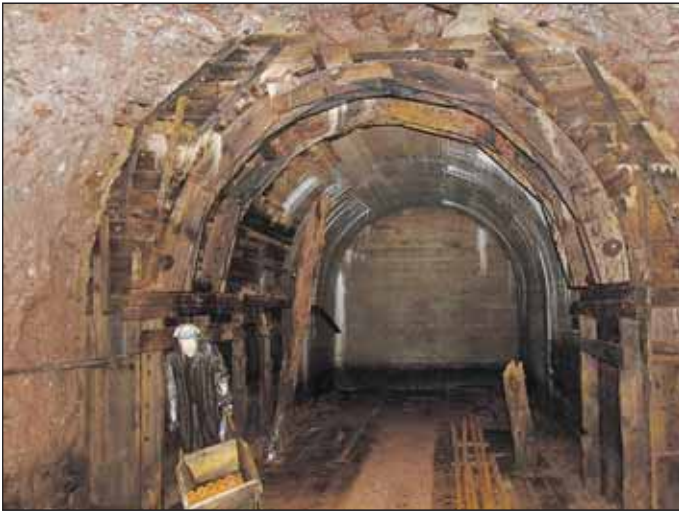
Obr. 9 Zednická výdřeva (skruže) v sále v podzemí tvrže Stachelberg
Fig. 9 Bricklayers' timbering (centering) in a hall in the Stachelberg fortress underground

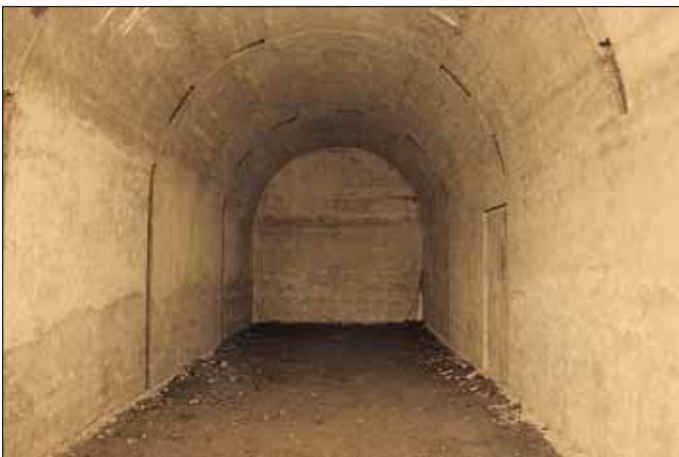
Obr. 14 Sál profilu 400/440 v podzemí tvrze Dobrošov s definitivním ostěním; podlaha nebyla vybetonována, v „kapsách“ ostění měly být fixovány cihelné příčky
Fig. 14 A 400/440-profile hall in the Dobrošov fortress underground with the final lining installed. The concrete floor concreting was not carried out. Brick partitions were to be fixed in mortises in the lining

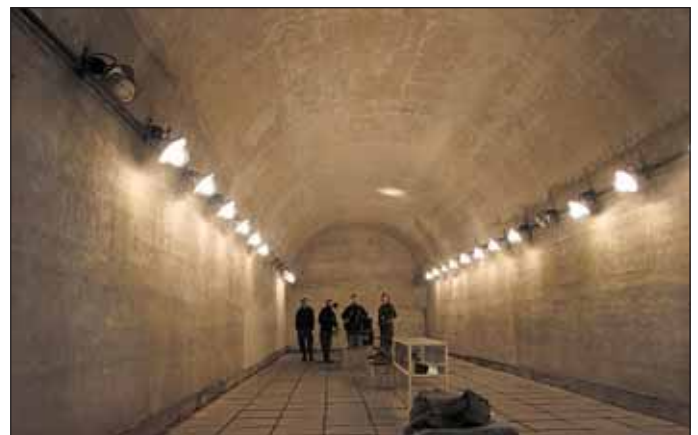
Obr. 15 Muniční sál profilu 520/460 v podzemí tvrze Dobrošov s definitivním ostěním; součást prohlídkového okruhu
Fig. 15 A 520/460-profile ammunition store room in the Dobrošov fortress underground with the final lining installed - part of the guided tour

Tvrz Dobrošov zasáhlo zastavení prací na konci září roku 1938 v nejvyšším tempu výstavby ostění (obr. 12, 13, 14, 15). Podle vyúčtovacích protokolů bylo v podzemí tvrže připraveno 3300 m² bednění, které pak bylo nepoužité demontováno v lednu 1939. Při betonážích v podzemí bylo spotřebováno celkem 2360 t cementu, což odpovídá kubatuře ostění zhruba 6000 m³. Přesto dokončený objem betonáže v podzemí představuje necelou polovinu plánovaného rozsahu.

The Dobrošov fortress was hit by the suspension of works at the end of September 1938, at the moment of the highest rates of the lining construction (see Figures 12, 13, 14 and 15). According to invoices, 3,300 m² of formwork were prepared in the fortress underground. It was dismantled in January 1939 without being used. The total of 2,360 tonnes of cement were consumed during the concreting in the underground. This amount roughly corresponds to the volume of the lining of 6,000 m³. On the other hand, the completed concrete casting volume represents less than a half of the planned extent.

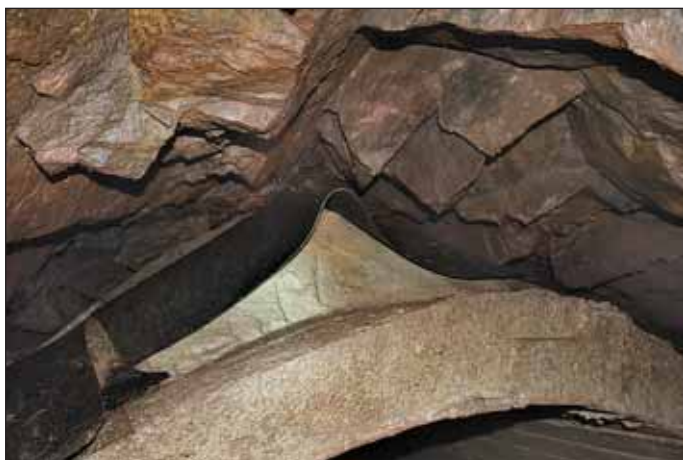
Obr. 18 Betonový „hřeben“ s izolací z lepenkových pásů na klenbě ostění hlavní galerie tvrze Dobrošov

Fig. 18 The concrete “crest” with waterproofing cardboard on the vault of the main gallery of the Dobrošov fortress

Vyjmenovaná opatření byla vzorově vypracována pro profily sálů 400/400 a 520/400. V případě menších profilů, především spojovacích chodeb, nebyla geometrie klenby měněna, jelikož její průřez byl navrhován jako kružnicový vždy. Dodatečná izolace lepenkovými pásy a železnými plechy, stejně jako nadbetonování „hřebenu“ bylo však využíváno i v těchto případech (obr. 18, 19).

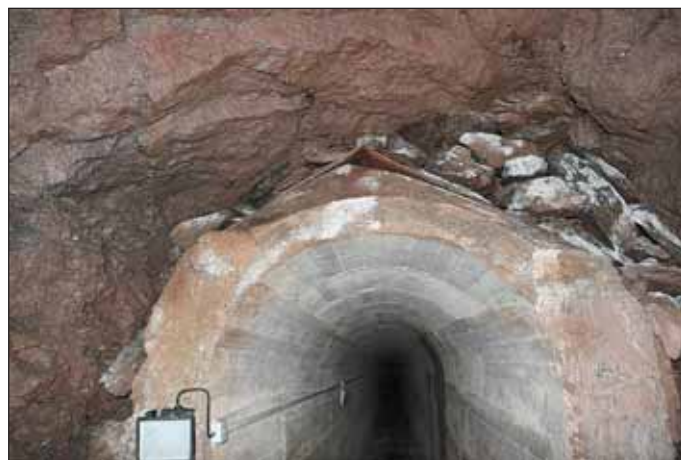
Obr. 19 Izolace klenby ostění s použitím střežovitého plechu na betonovém „hřebenu“ u hlavní galerie tvrze Dobrošov

Fig. 19 Waterproofing on a lining vault using roof-like steel sheets on the concrete “crest” at the main gallery of the Dobrošov fortress

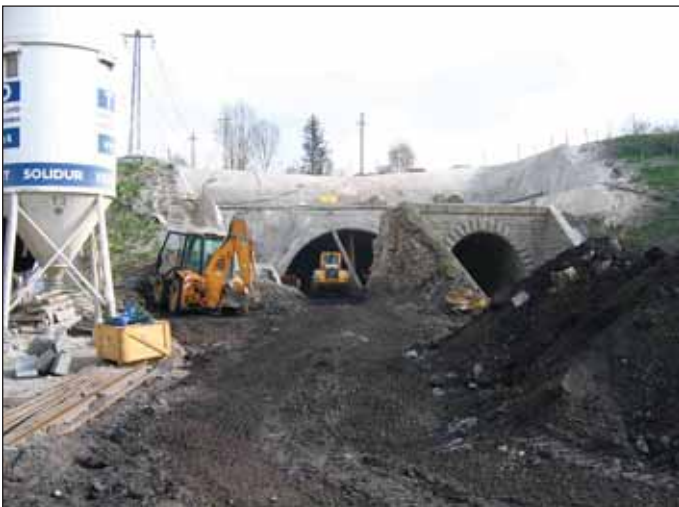
Obr. 4 Jižní portál tunelu Jablunkov č. II – výstavba nového portálu (2008)
Fig. 4 Southern portal of the Jablunkov No. 2 tunnel – construction of a new portal (2008)

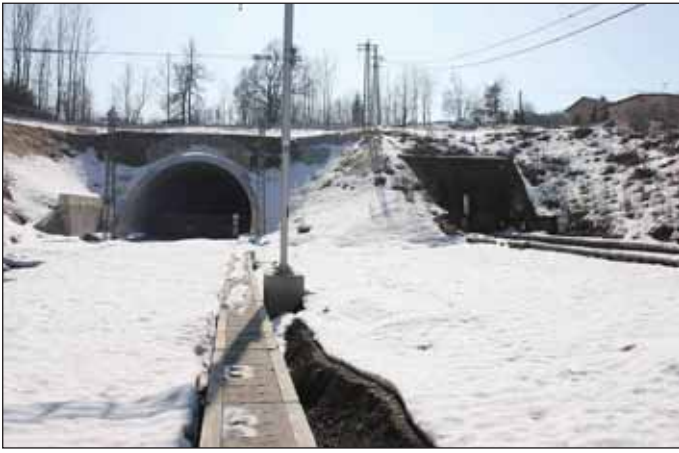
Obr. 5 Severní portály – nový a provozovaný tunel (2012)
Fig. 5 Northern portals – the new tunnel and operating tunnel (2012)

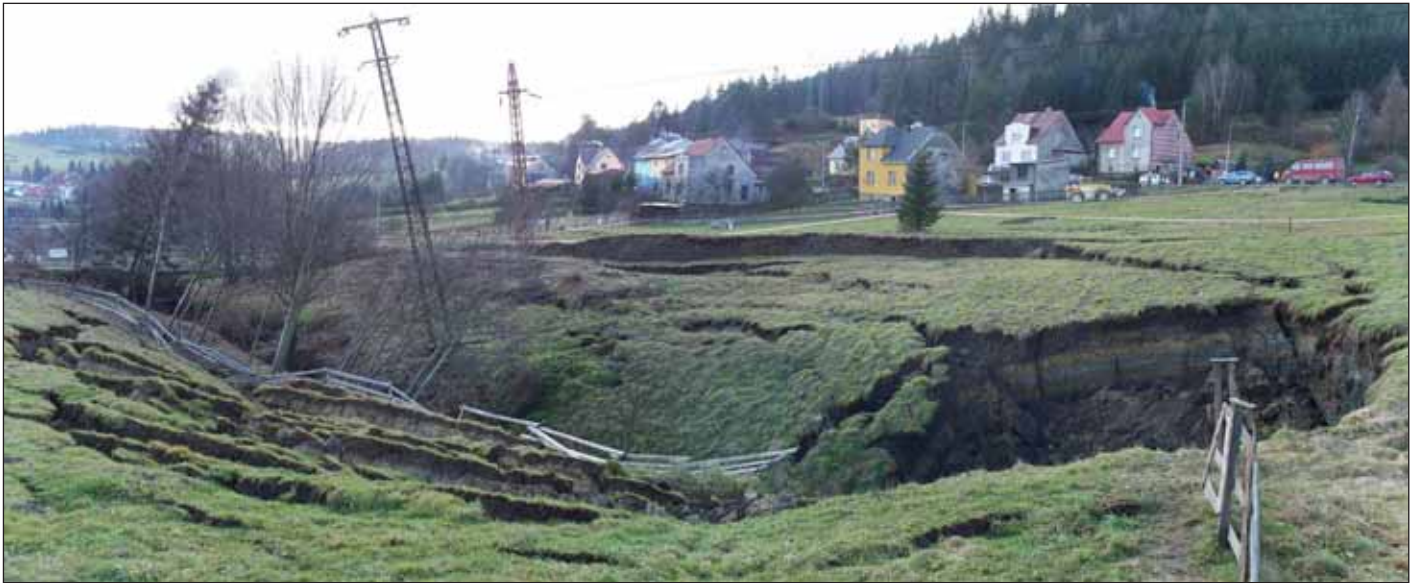
Obr. 6 Deformace terénu po závalových událostech (2009)
Fig. 6 Terrain deformations after the collapse events (2009)

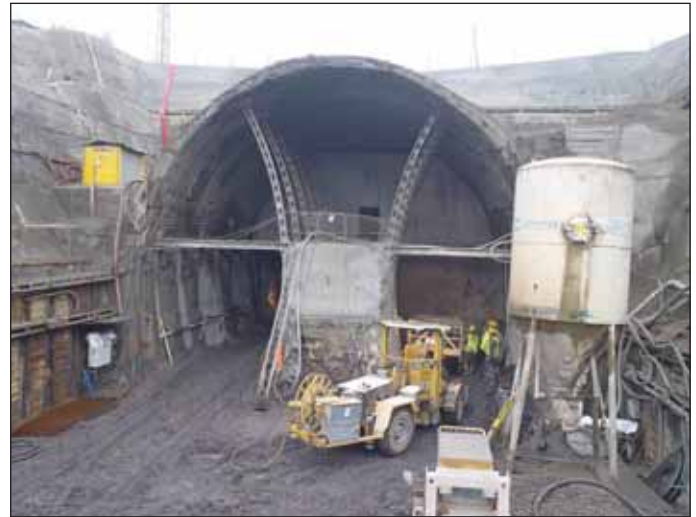
Obr. 7 Jižní portál tunelu Jablunkov – zmáhání závalů (12/2011)

Fig. 7 Southern portal of the Jablunkov tunnel – recovering work (12/2011)

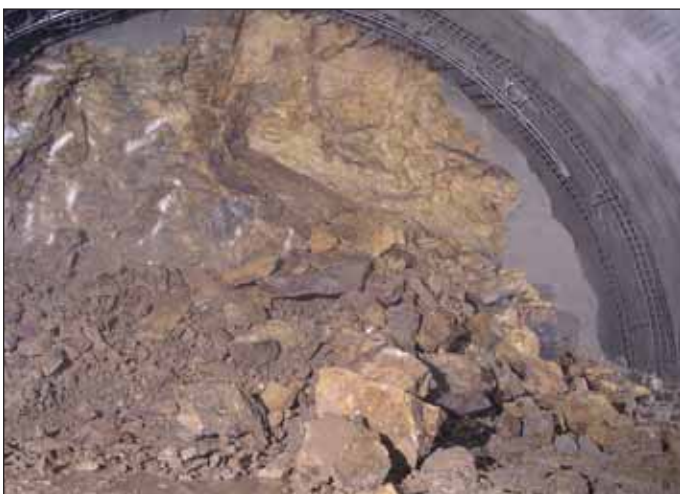
Obr. 1 Vypadnutí části čelby v TM 147,9 (RNDr. P. Novotný)
Fig. 1 Collapse of a part of the excavation face at tunnel chainage m 147.9 (RNDr. P. Novotný)

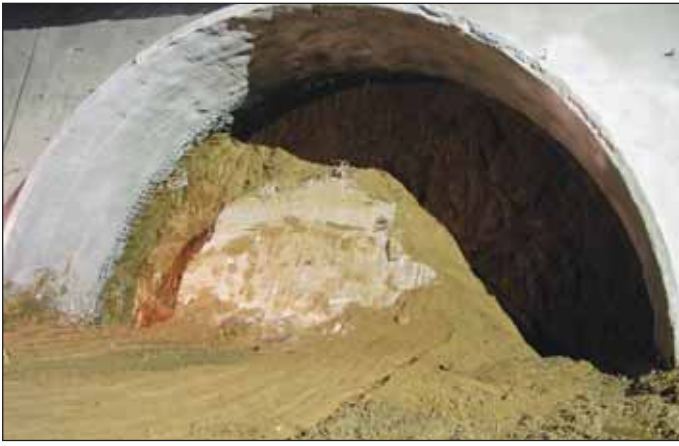
Obr. 2 Počátek ražeb z jižního portálu v silně zvětralých rulách (Ing. J. Svatoš)
Fig. 2 Commencement of tunnelling through heavily weathered gneiss from the southern portal (Ing. J. Svatoš)

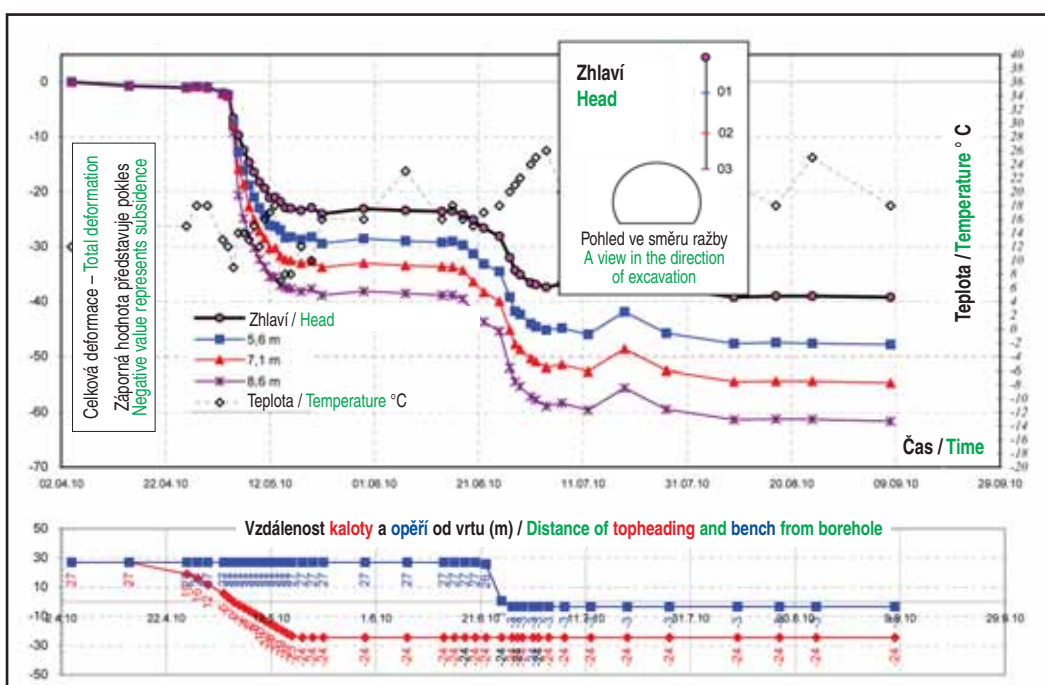
Obr. 5 Deformace z extenzometru naměřené ve staničení TM 393
Fig. 5 Deformations measured by extensometer at tunnel chainage m 393

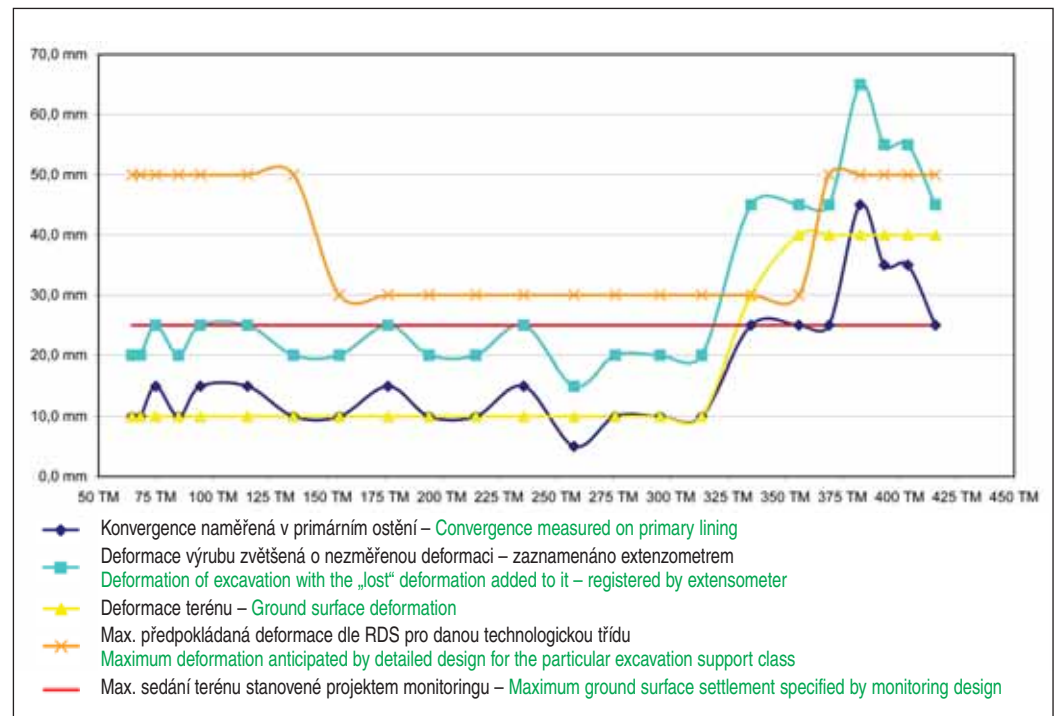
Obr. 6 Průběh deformací po délce tunelu

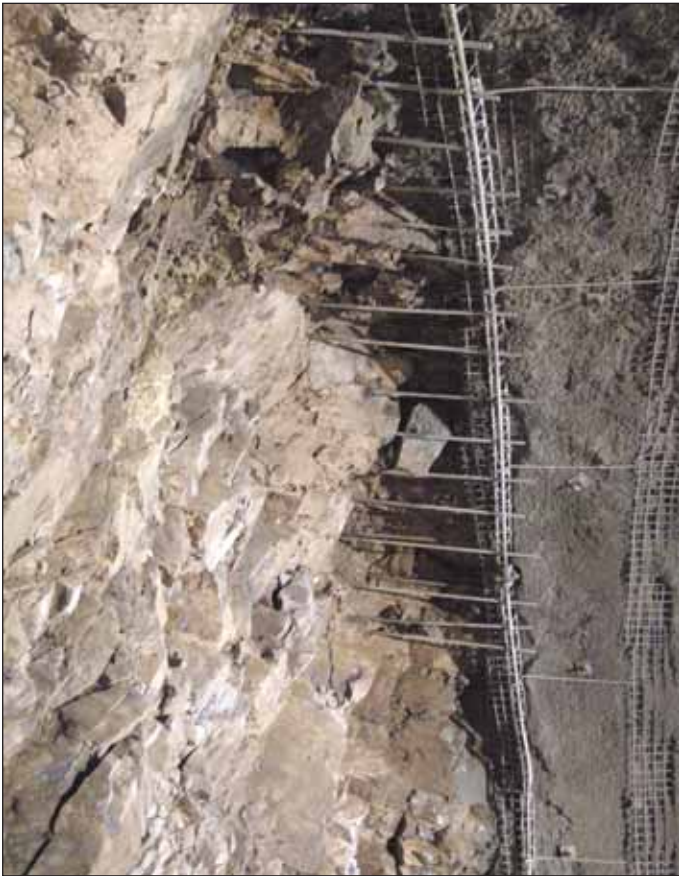
Obr. 7 Přístropí silně postižené diskontinuitami se zajištěním ocelovými jehlami – Tunel Tomický II (RNDr. E. Straka)

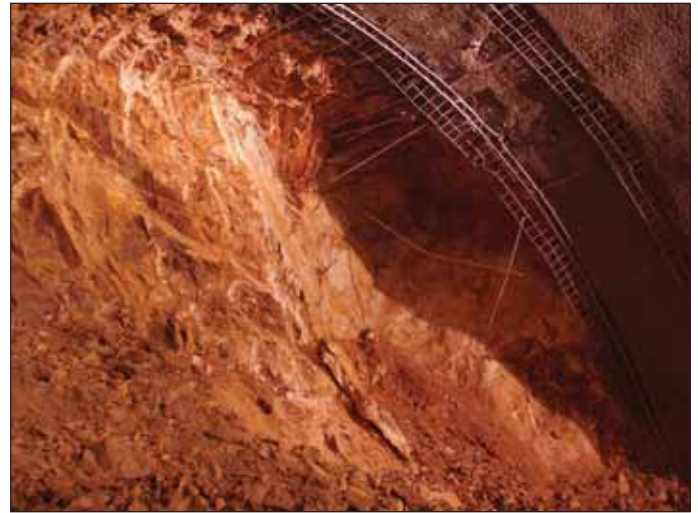
Obr. 8 Nadvýlom u tunelu Tomický I (Ing. J. Svatoš)

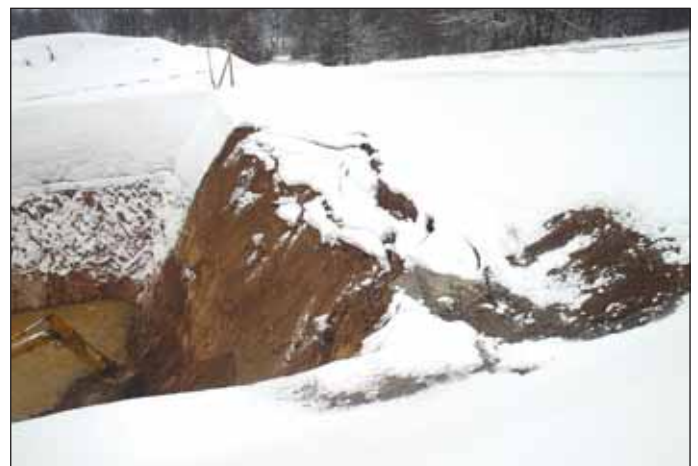
Obr. 9 Zátrh výjezdového portálu tunelu Tomický II po predisponované ploše
Fig. 9 Slide scar at the Tomice No. 2 tunnel exit portal (sliding along a pre-disposed surface)

Compared with the Olbramovice tunnel and Tomice No. 1 tunnel, the Tomice No. 2 tunnel differed in terms of the rock mass quality along the tunnel. Whilst, in the case of the Olbramovice and Tomice No. 1 tunnels, the lowest quality rock was encountered in portal sections and the quality improved toward the mid points, the best condition of rock mass in the Tomice No. 2 tunnel was encountered at the beginning of the excavation, at the entrance (southern) portal. The geological conditions gradually deteriorated with the excavation advancing. The unfavourable geology in the area of the exit (northern) portal of the Tomice No. 2 tunnel is proved by the fact that the exit portal wall collapsed shortly after the excavation of the construction pit (see Fig. 9).

Tunel Tomický II byl oproti tunelům Olbramovický a Tomický I odlišný v rozložení kvality horninového masivu po délce tunelu. U tunelů Olbramovický a Tomický I byla nejméně kvalitní hornina zastížena v příportálových úsecích a směrem do jejich středu se kvalita zlepšovala. U tunelu Tomický II byla nejlepší kondice horninového masivu zastížena v počátku ražby na vjezdovém (jižním) portále. Postupně s ražbou se ale geologické poměry zhoršovaly. Nepříznivou geologií v oblasti výjezdového (severního) portálu Tomického II tunelu dokládá skutečnost, že výjezdová portálová stěna krátce po vyhloubení jámy zkolabovala – viz obrázek 9.

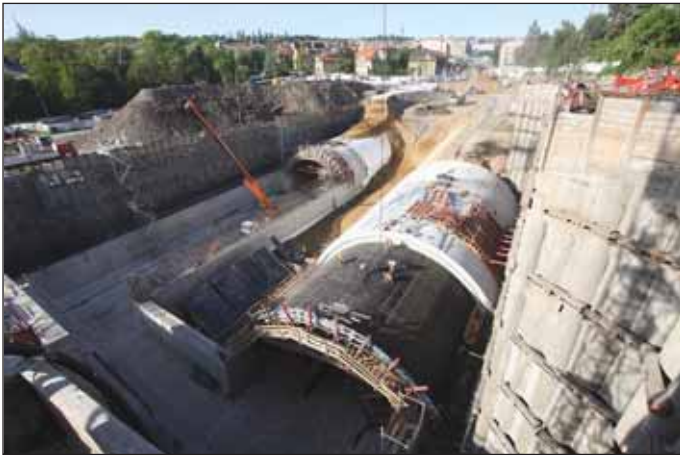
Obr. 1 Výstavba klenbových tunelů v jámě Patočkova
Fig. 1 Construction of vaulted tunnels in the Patočkova construction pit

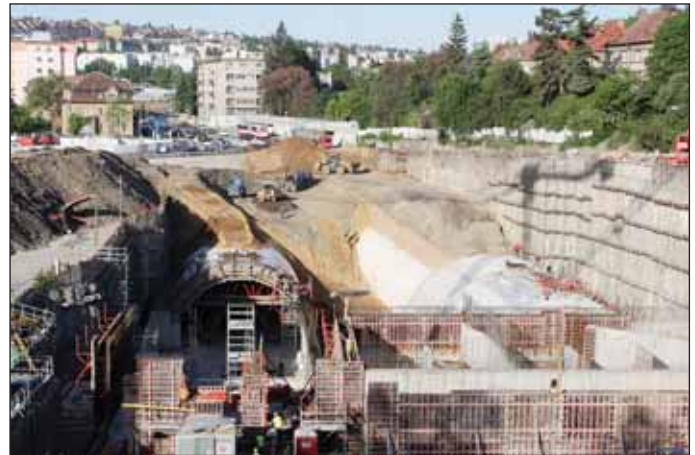
Obr. 2 Výstavba klenbových tunelů v jámě Patočkova
Fig. 2 Construction of vaulted tunnels in the Patočkova construction pit

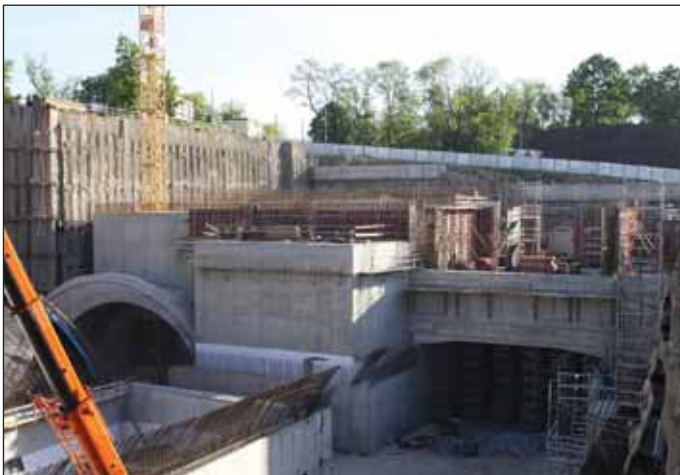
Obr. 3 Výstavba technologického centra TGCI Myslbekova
Fig. 3 Construction of the TGCI Myslbekova technical centre

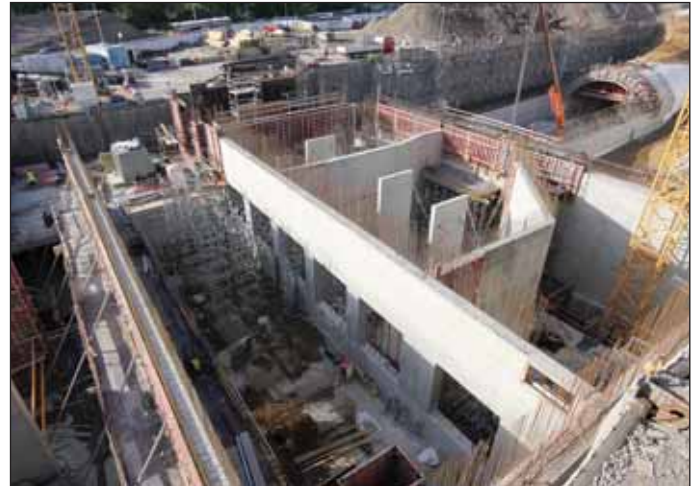
Obr. 4 Objekt technologického centra TGCI Myslbekova
Fig. 4 TGCI Myslbekova service building

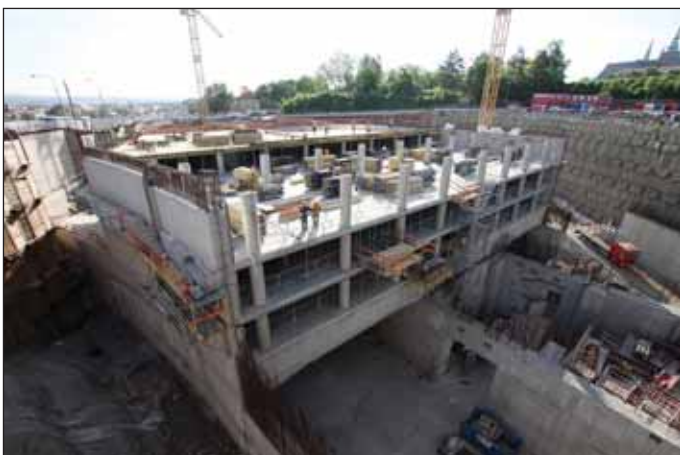
Obr. 5 Staveniště hloubených tunelů, TGC2 a podzemních garáží na Prašném mostě
Fig. 5 Construction site for cut-and-cover tunnels, the TGC2 centre and an underground car park at Prašný Most

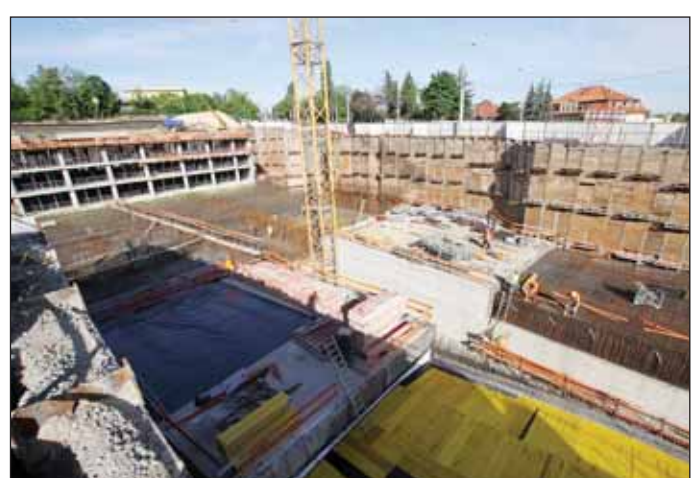
Obr. 6 Armování, bednění a betonáž stropu tunelů na Prašném mostě
Fig. 6 Installation of reinforcement and formwork and casting of tunnel roof deck at Prašný Most

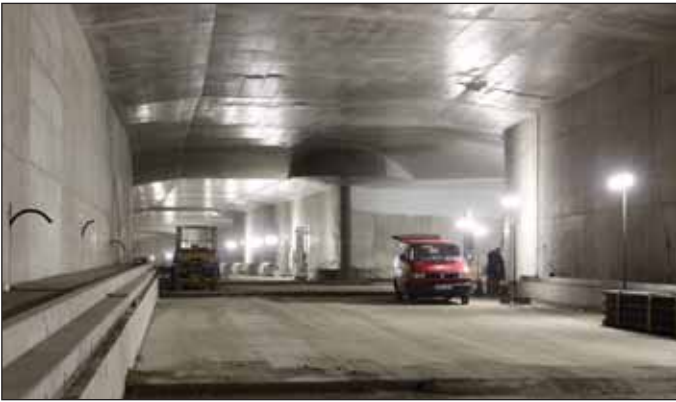
Obr. 7 Dokončovací práce v hloubených tunelech u Špejcharu
Fig. 7 Finishing work in cut-and-cover tunnels at Špejchar

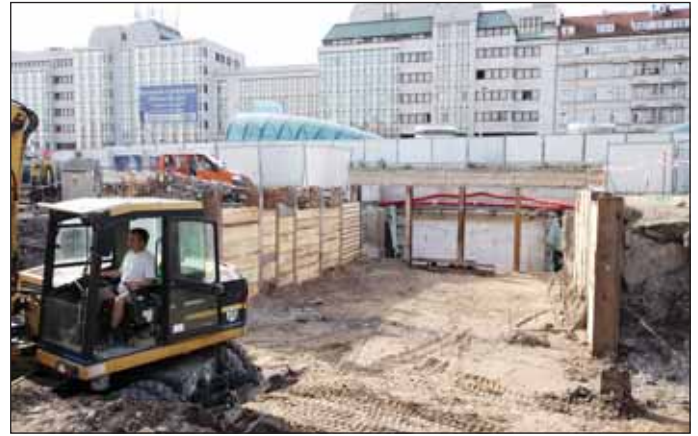
Obr. 8 Na Hradčanské probíhá dostavba podchodu pod tratí ČD směrem do Dejvic
Fig. 8 Completing of the pedestrian subway under Czech Railways track toward Dejvice is underway at Hradčanská metro station

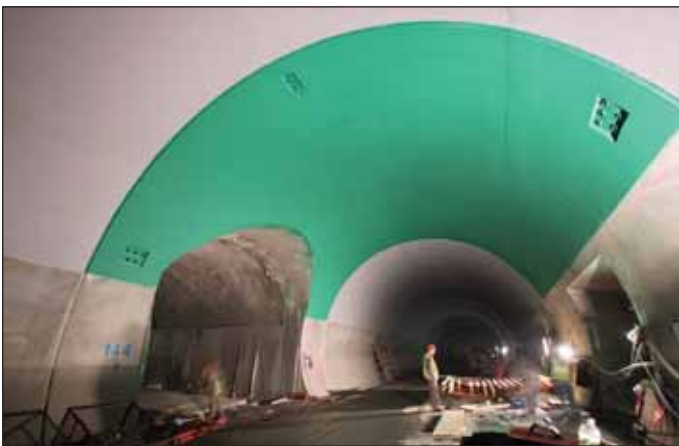
Obr. 9 Nátěr klenby raženého tunelu v křížení s tunelovou propojkou TP14
Fig. 9 Coating applied to the vault of the mined tunnel at the intersection with the cross passage TP14

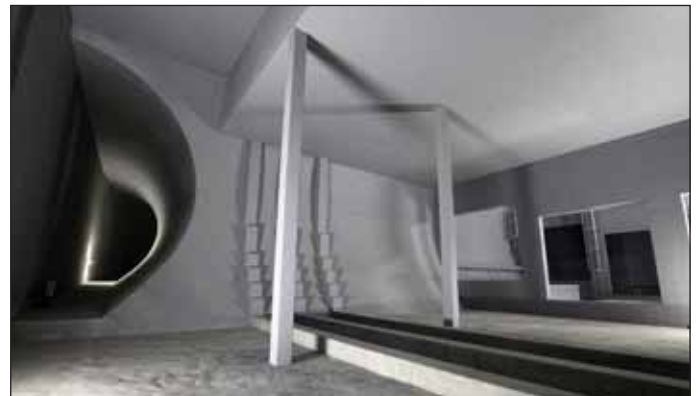
Obr. 10 Prostor pro ventilátory v ražené strojovně vzduchotechniky
Fig. 10 Space for fans in the mined cavern for ventilation plant

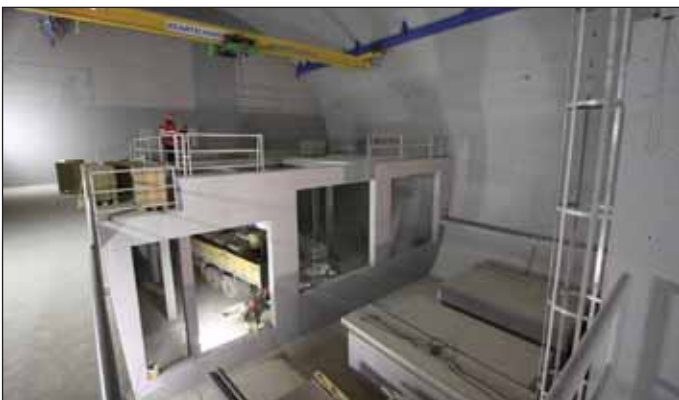
Obr. 11 Jeden z prostorů pro hlavní ventilátory v ražené strojovně vzduchotechniky
Fig. 11 One of the spaces for main fans in the mined cavern for the ventilation plant

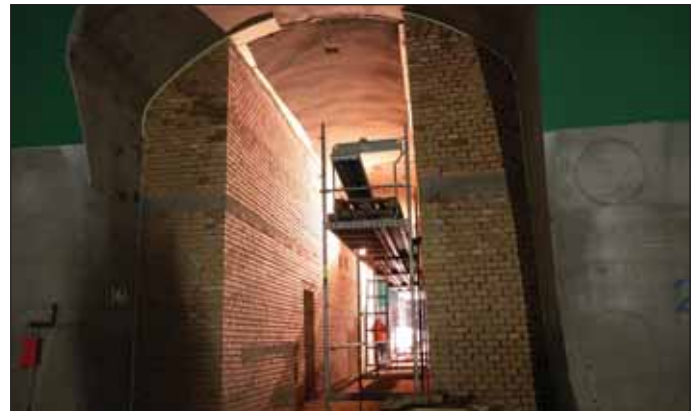
Obr. 12 Zdění příček v tunelové propojce TP12
Fig. 12 Erection of masonry partitions in cross passage TP12

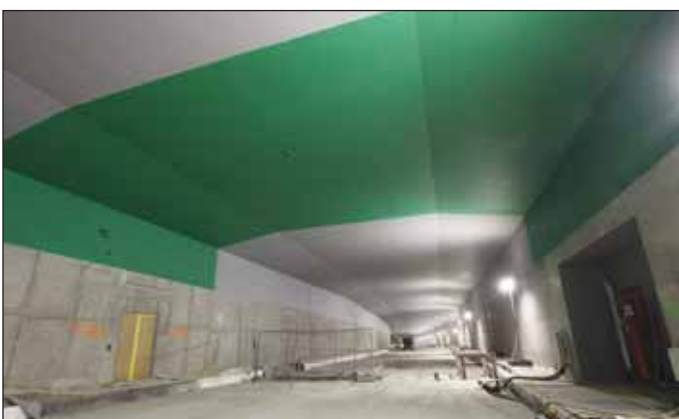
Obr. 13 Nátěr klenby v hloubeném tunelu na Letné
Fig. 13 Coating applied to the vault of the Letná cut-and-cover tunnel

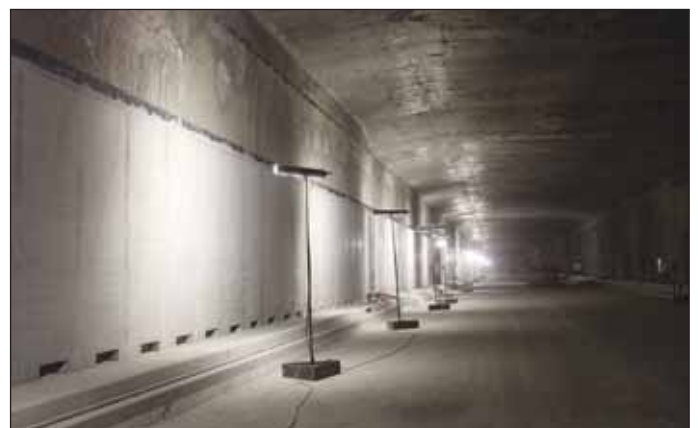
Obr. 14 Finální povrchová úprava milánských stěn v tunelech u Špejcharu
Fig. 14 Final work of a Špejchar tunnel diaphragm walls

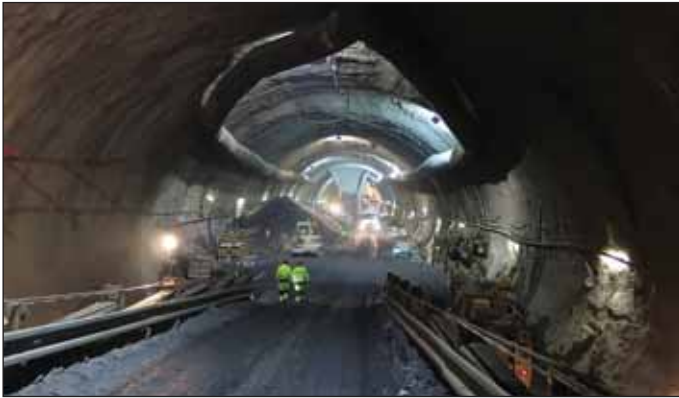
Obr. 1 Členění ražeb stanice Červený vrch
Fig. 1 The Červený Vrch station excavation sequence

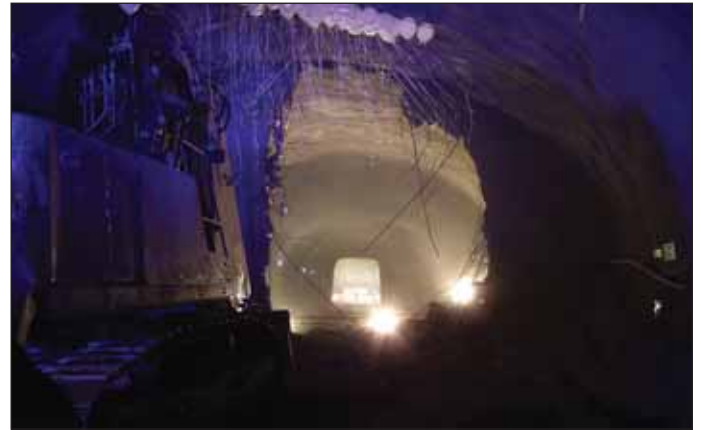
Obr. 2 Expresivní foto z prorážky tratových tunelů ražených NRTM v úseku Motol - Vypich (foto: Ing. Libor Mařík)
Fig. 2 Expressive picture from the breakthrough of running tunnels driven using the NATM in the Motol - Vypich section (Photo courtesy of Ing. Libor Mařík)

Právě dokončený úsek traťových dvoukolejných tunelů mezi budoucí stanicí Nemocnice Motol a Vypichem má včetně tak zvané montážní komory celkovou délku 735 m. Úsek byl ražen ve dvou etapách, z důvodu potřeby uvolnit koncem roku 2010 montážní komoru a přístupovou štolu Kateřina Metrostavu pro přípravu ražeb zeminovými štíty.

V první etapě ražeb dlouhé 255 m postupovaly ražby z Vypichu směrem do Motola. Plocha výrubu obnáší zhruba 90 m². Vedení trasy dvoukolejných tunelů ražených metodou NRTM bylo zvoleno z bezpečnostních důvodů v prostoru, ve kterém se nenachází žádná povrchová zástavba. I přes nepříznivé geologické podmínky se dařilo pomocí aplikace správných tříd těžby a nasazení

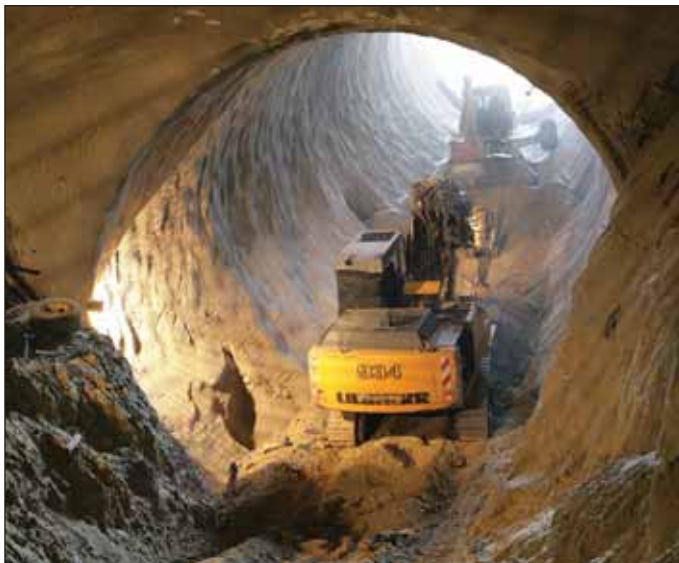
Obr. 3 Proražený eskalátorový tunel pro stanici Petřiny (foto: Josef Husák)
Fig. 3 Escalator tunnel for the Petřiny station after breakthrough (Photo courtesy of Josef Husák)

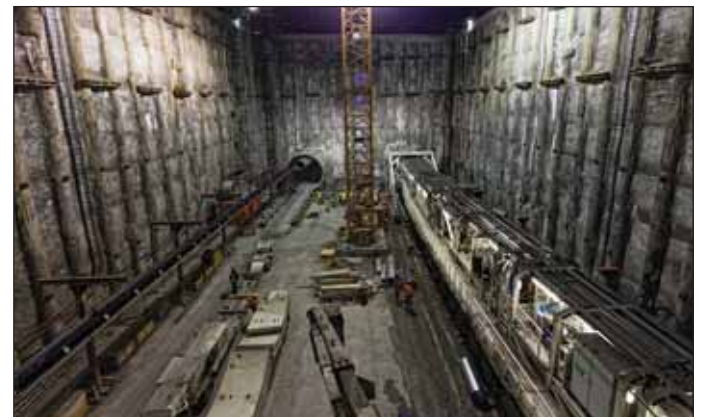
Obr. 4 Protažení zeminového štítu jámou E2 ve Veveřslavíně
Fig. 4 Pulling the EPBM through construction pit E2 in Veveřslavín

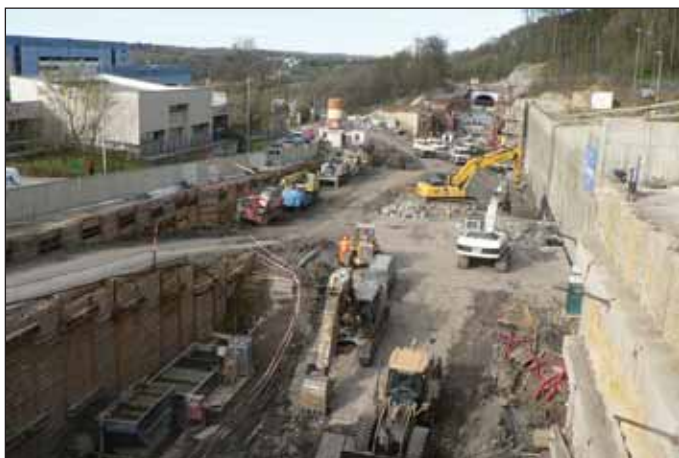
Obr. 5 Rozpracovaná povrchová stanice Motol (foto: Ing. Marián Chotár)
Fig. 5 The Motol at-grade station under construction (Photo courtesy of Ing. Marián Chotár)

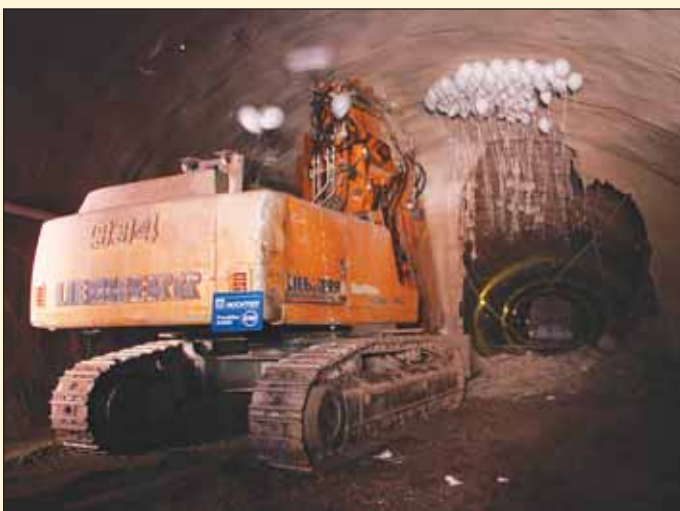
Obr. 1 Prorážka se uskutečnila v TM 480
Fig. 1 The tunnel broke through at tunnel chainage metre TM 480

Po dalším přesunu zařízení staveniště přímo do prostoru stanice Nemocnice Motol byly započaty ražby druhé etapy traťových dvoukolejných tunelů, dlouhé 480 m z Motola směrem na Vypich. Na tomto úseku se nachází v prvních 100 m území se svahovými blokovými sesuvy, které vynutily zpomalené postupy s vertikálně členěnou ražbou. Po opuštění ražeb pomocí postranní stoly přešly ražby do horizontálního členění čelby. Po zhruba dalších 80 m ražeb dvoukolejných tunelů nafarali raziči společnosti HOCHTIEF Solutions AG tektonicky porušenou zónu pražského zlomu nacházející se zhruba v prostoru zaústění vzduchotechnické stoly. Vzniklý geologicky podmíněný nadvýlom byl profesionálně zmáhan a zajištěn. V dalším průběhu ražeb probíhaly postupy bez nepředvídaných překážek v souladu s projektem. Dne 3. 4. 2012 se oba protiběžně ražené tunely setkaly ve staničení TM 480. Prorážka proběhla s neobvykle velikou přesností. Maximální odchylka nepřevyšovala 5 mm. Razičské práce vyvrcholily organizovanou slavnostní prorážkou, která byla důstojným oceněním těžké práce razičů a zodpovědného přístupu zhotovitele. Ražby proběhly bez mimořádných událostí a vážných zranění.
